Phase I Environmental Site Assessment – McKamey Site Gregory, San Patricio County, Texas

February 2018

Prepared for Corpus Christi Regional Economic Development Corporation

Hanson Professional Services Inc. Project No. 18L0013 Task 1000

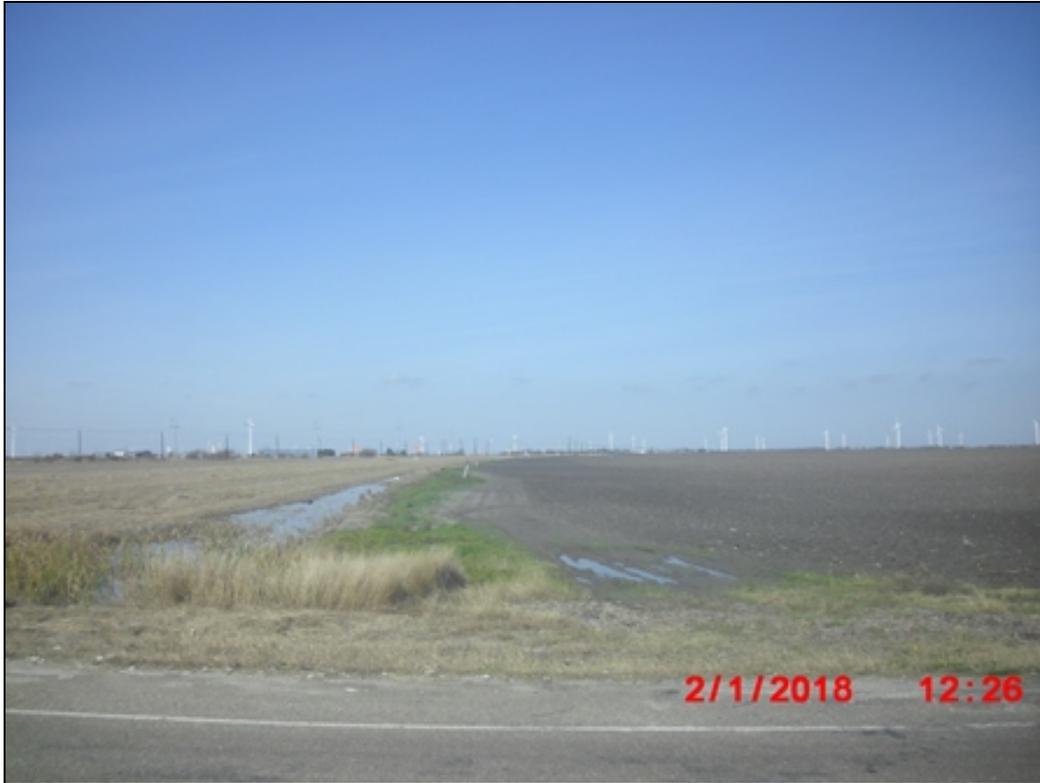
1. Photo taken near southeast corner of subject property facing northwest. Farmland of the subject property and a right of way for U.S. Highway 181 can be seen.

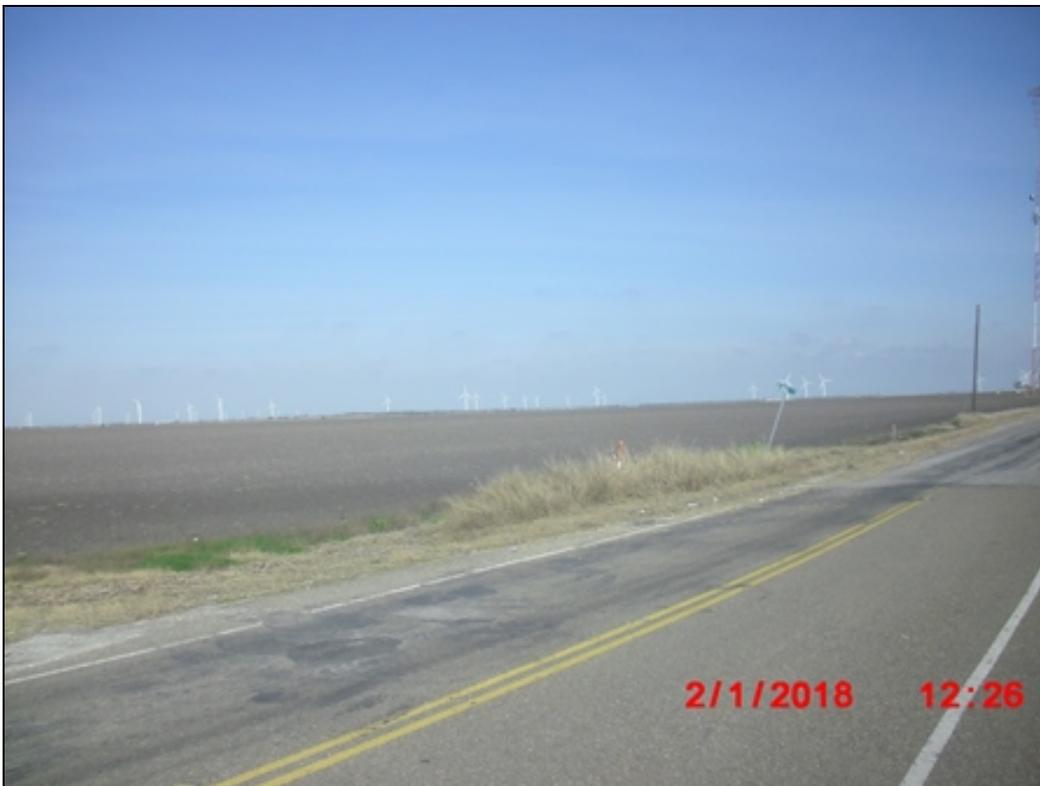
2. Photo taken near southeast corner of subject property facing north. Farmland of the subject property can be seen across CR 3865.

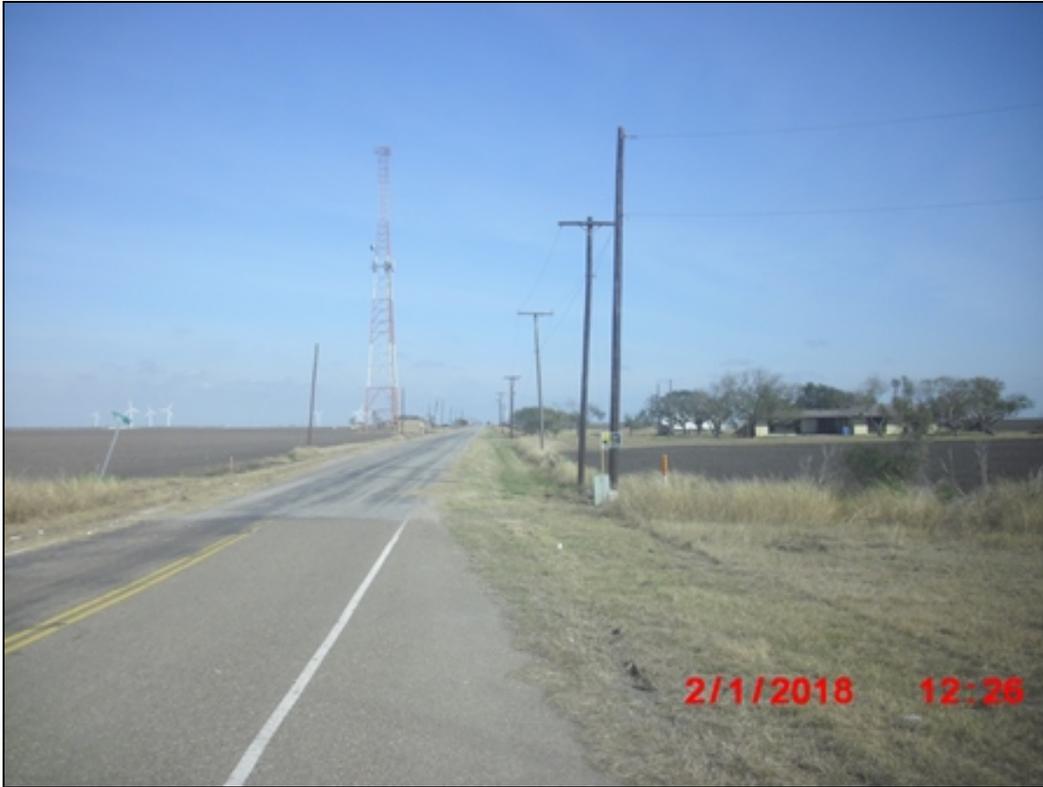
3. Photo taken near southeast corner of subject property facing northeast. CR 3865 can be seen between the subject property and the adjacent property to the east.

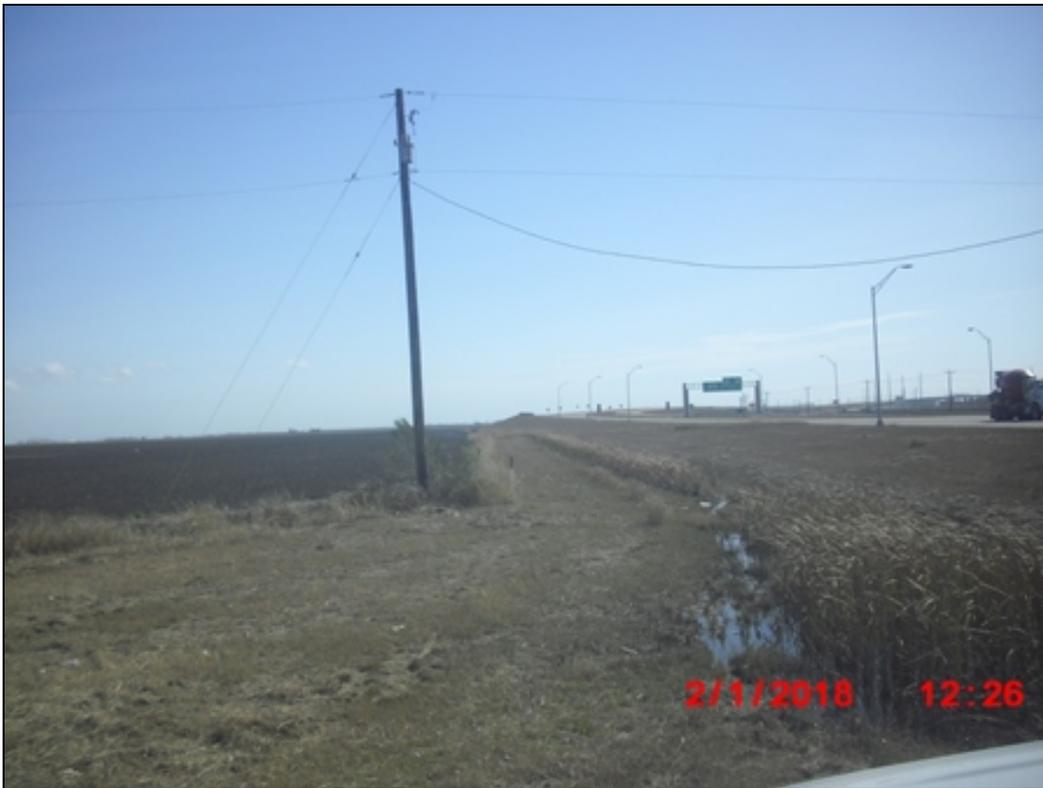
4. Photo taken near southeast corner of subject property facing southeast. The adjacent property to the east and a right-of-way for U.S. Highway 181 can be seen.

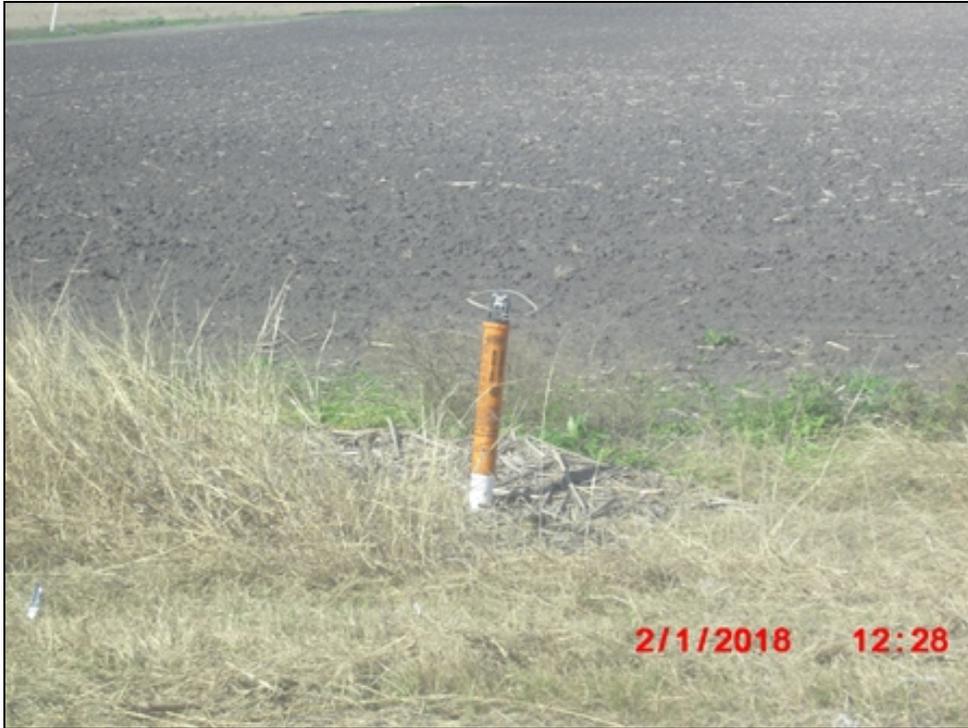
5. Photo taken approximately 120 feet north of southeast corner of subject property facing west. A buried cable warning marker can be seen on the subject property.

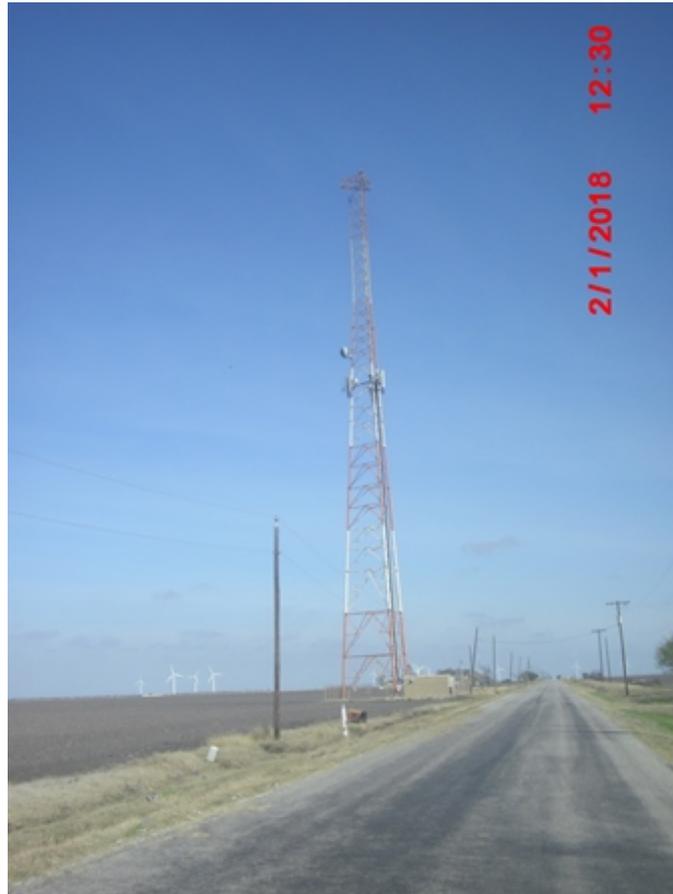
6. Photo taken approximately 550 feet north of subject property facing northeast. A communications tower and electric distribution lines can be seen on the subject property.

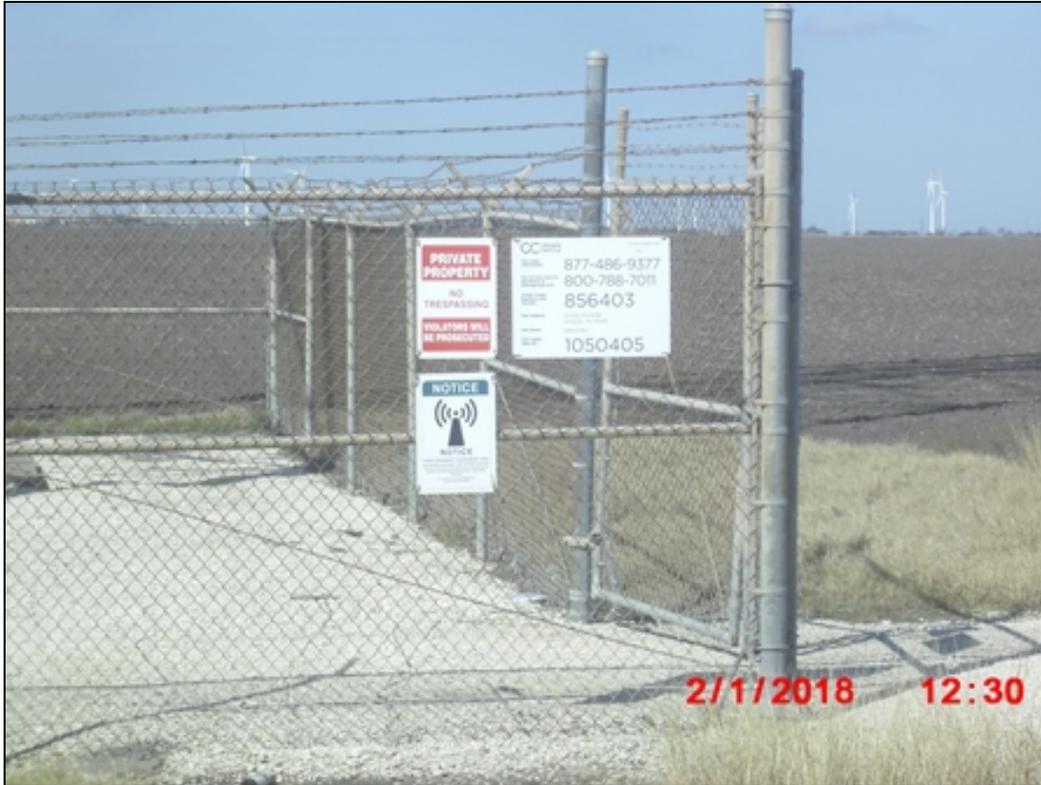
7. Photo taken to east of communications tower facing west. A sign containing contact information and warning signs can be seen on the fence surrounding the tower.

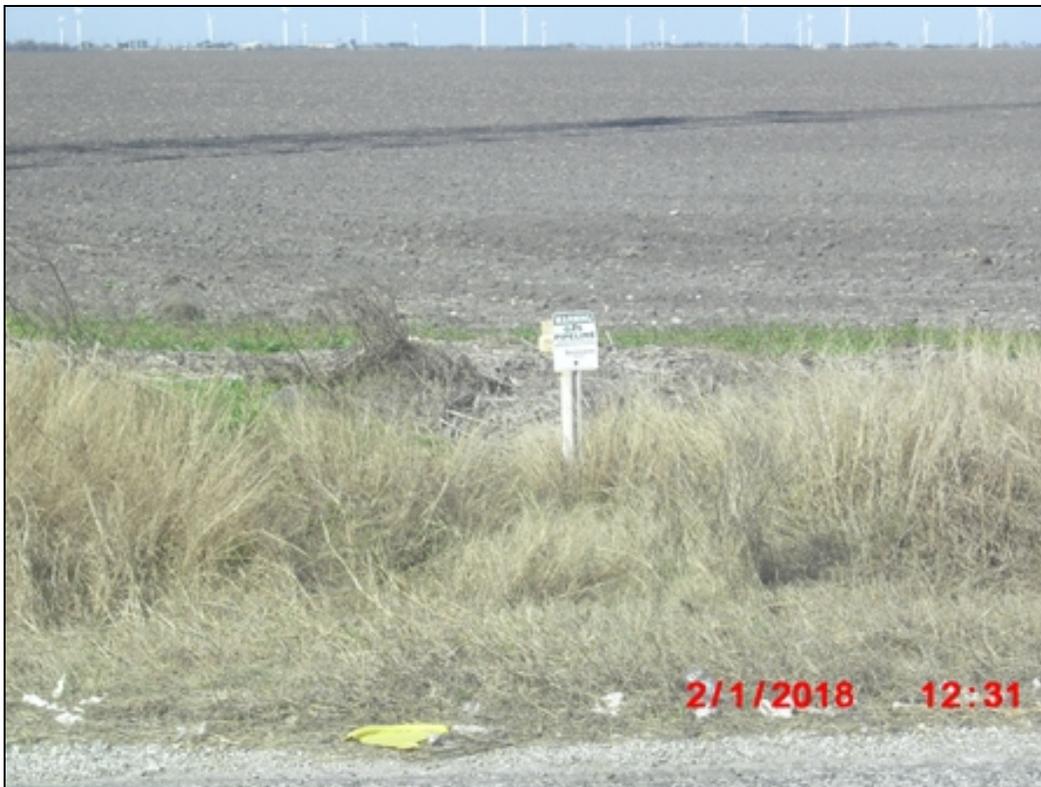
8. Photo taken approximately 1,120 feet north of southeast corner of subject property facing west. A warning marker for a gas pipeline can be seen.

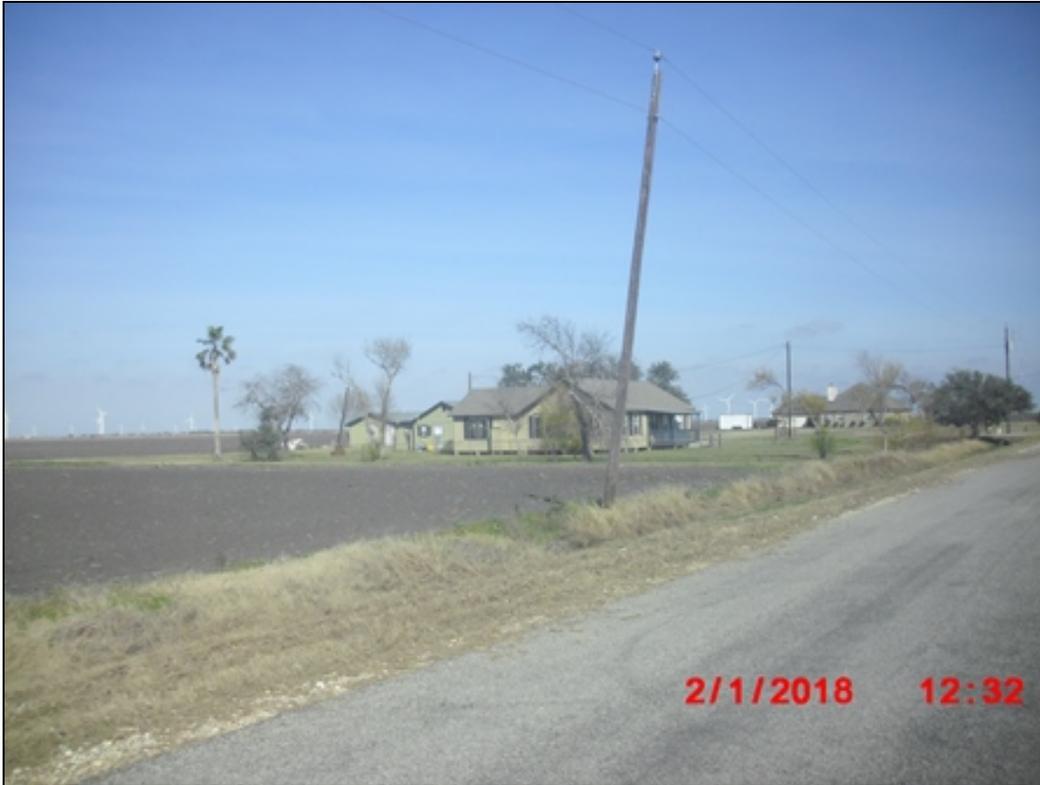
9. Photo taken approximately 1,900 feet north of southeast corner of subject property facing north. A residential property on the southeast portion of the subject property can be seen.

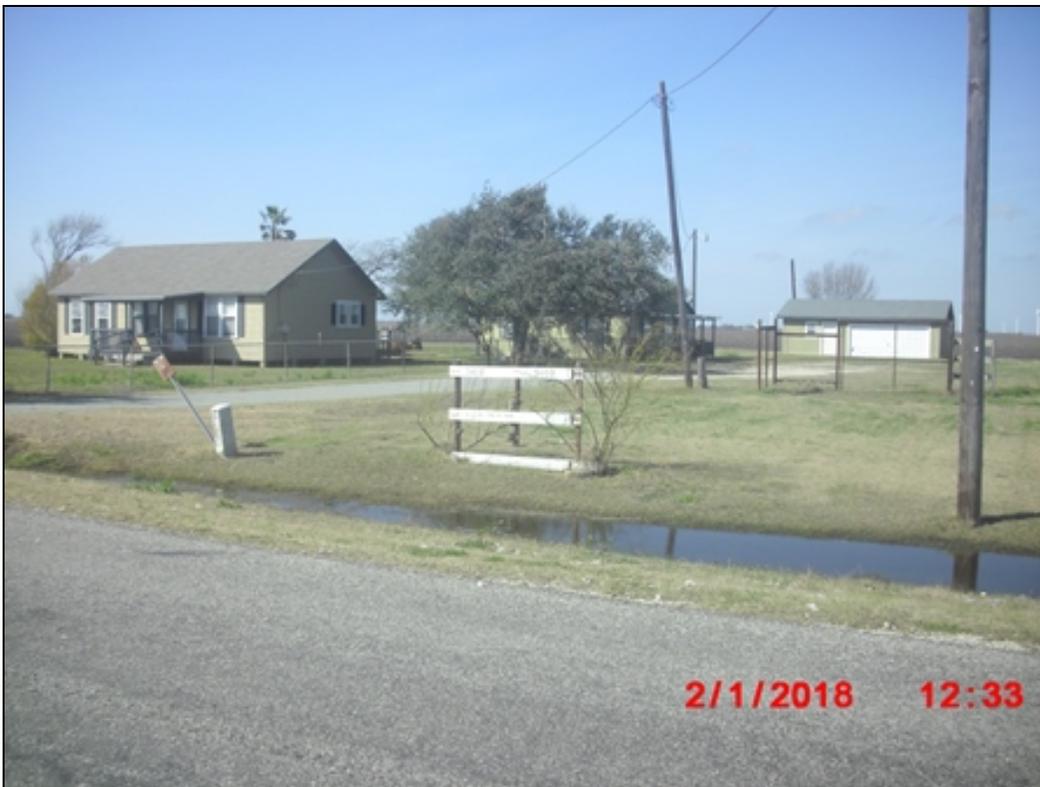
10. Photo taken approximately 2,220 feet north of southeast corner of subject property facing west. Warning markers for buried cables and a sign indicating the addresses of two residential homes in this area (5407 and 5409 CR 3865) can be seen.

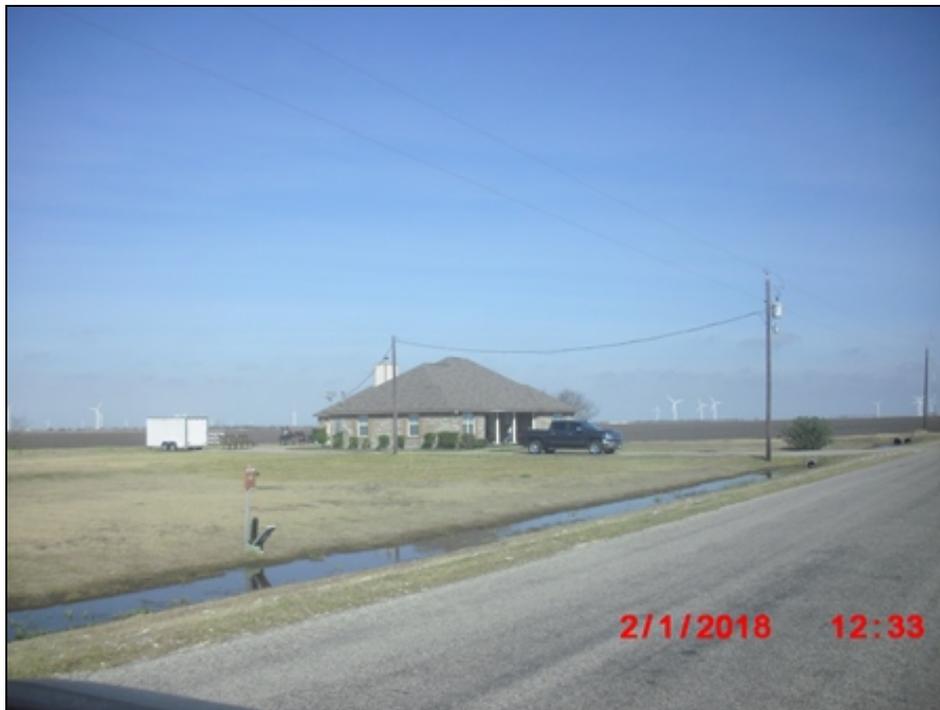
11. Photo taken approximately 2,220 feet north of southeast corner of subject property facing north. A residential property on the southeast portion of the subject property can be seen.

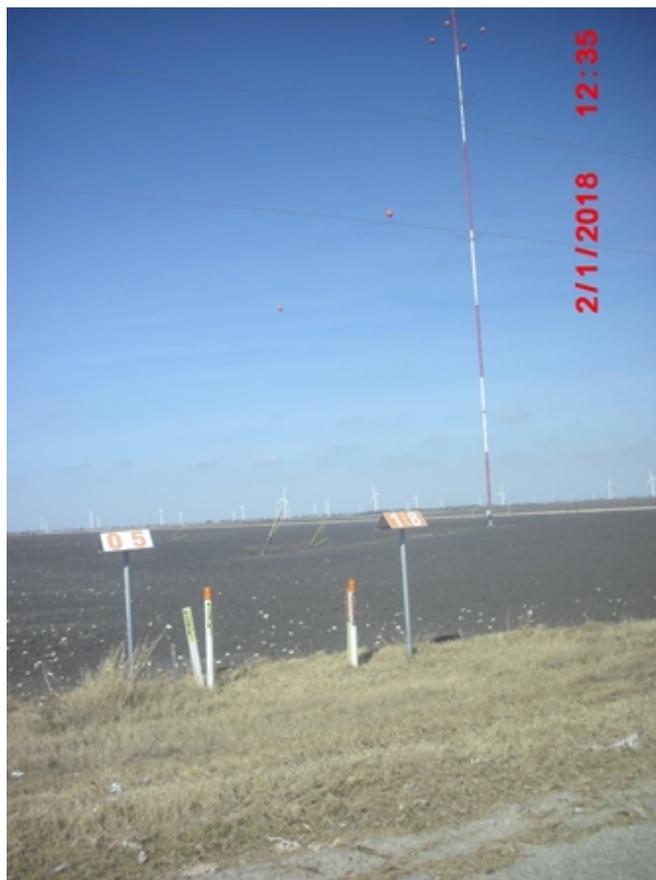
12. Photo taken approximately 4,400 feet north of southeast corner of subject property facing northwest. On the property adjacent to the subject property, two aerial pipeline markers and three warning markers for an LPG and a crude oil pipeline can be seen. In the distance, a communications tower can be seen.

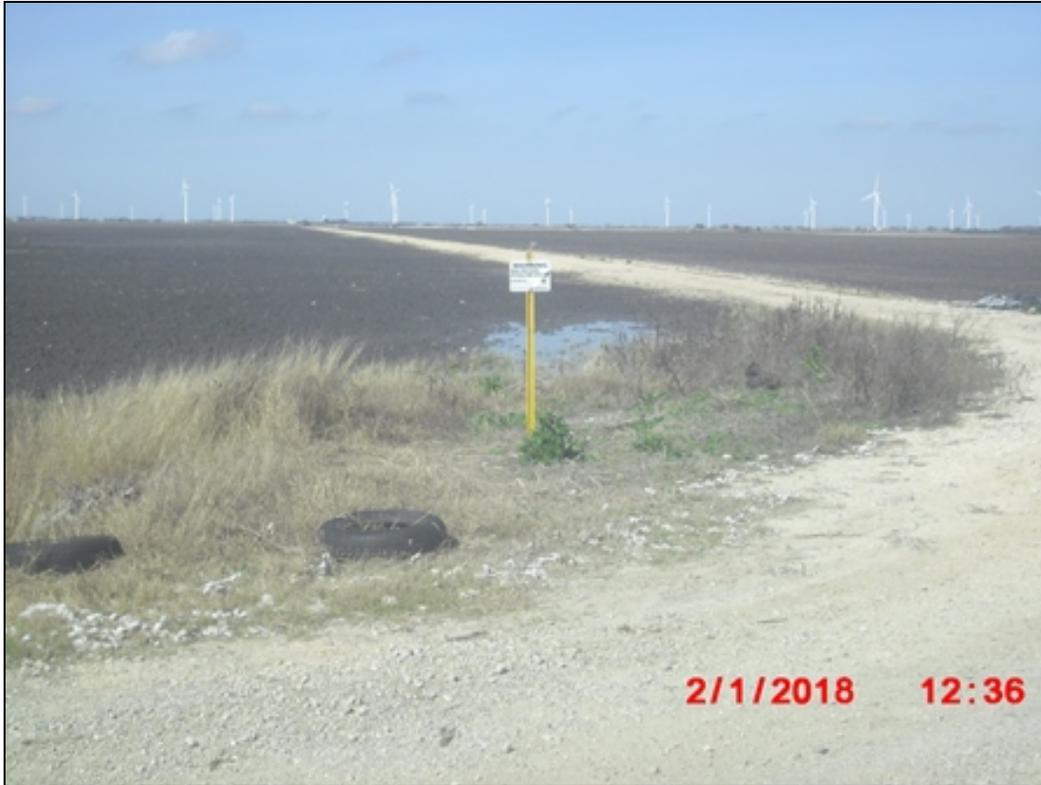
13. Photo taken approximately 4,750 feet north of southeast corner of subject property facing northwest. On the property adjacent to the subject property, a warning marker for a high pressure petroleum pipeline can be seen.

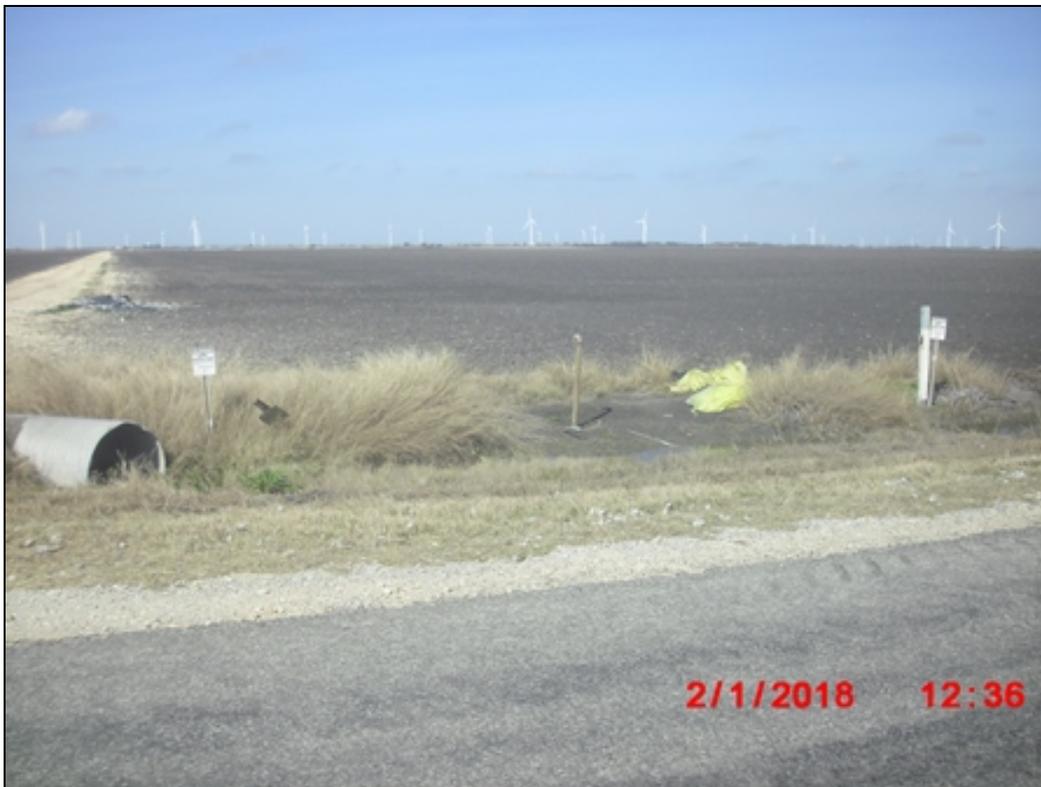
14. Photo taken approximately 4,830 feet north of southeast corner of subject property facing west. Two warning markers for gas pipelines can be seen.

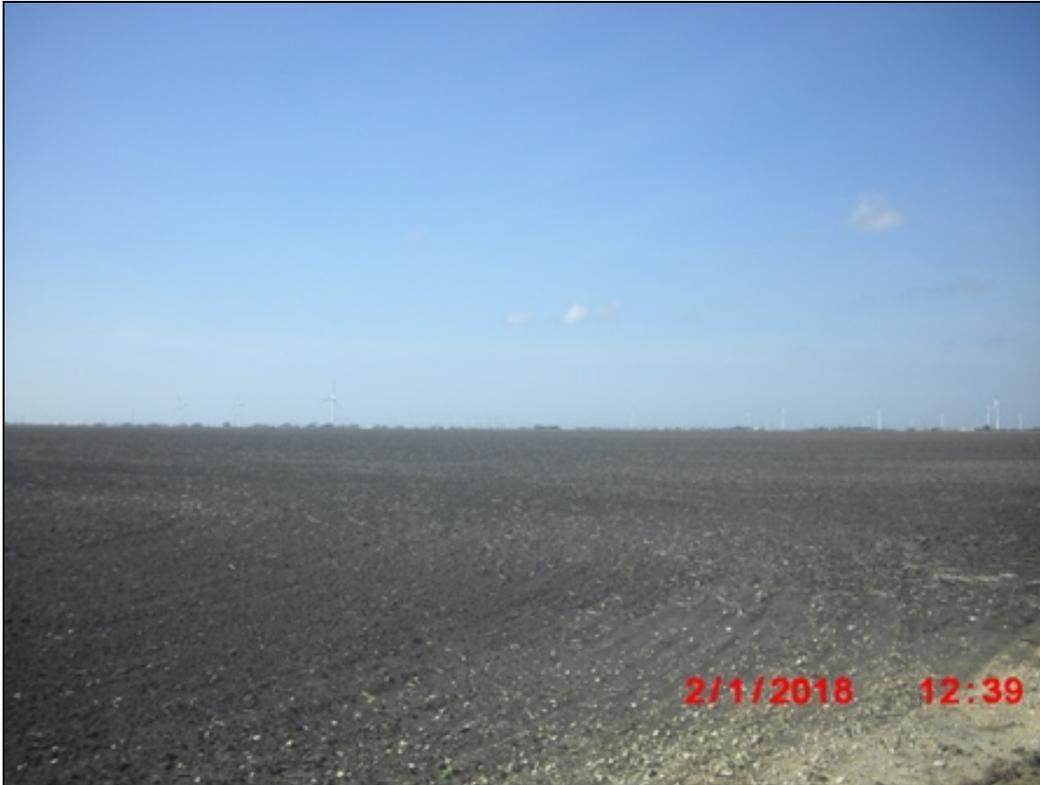
15. Photo taken near center of eastern property boundary facing north. Farmland of the subject property can be seen.

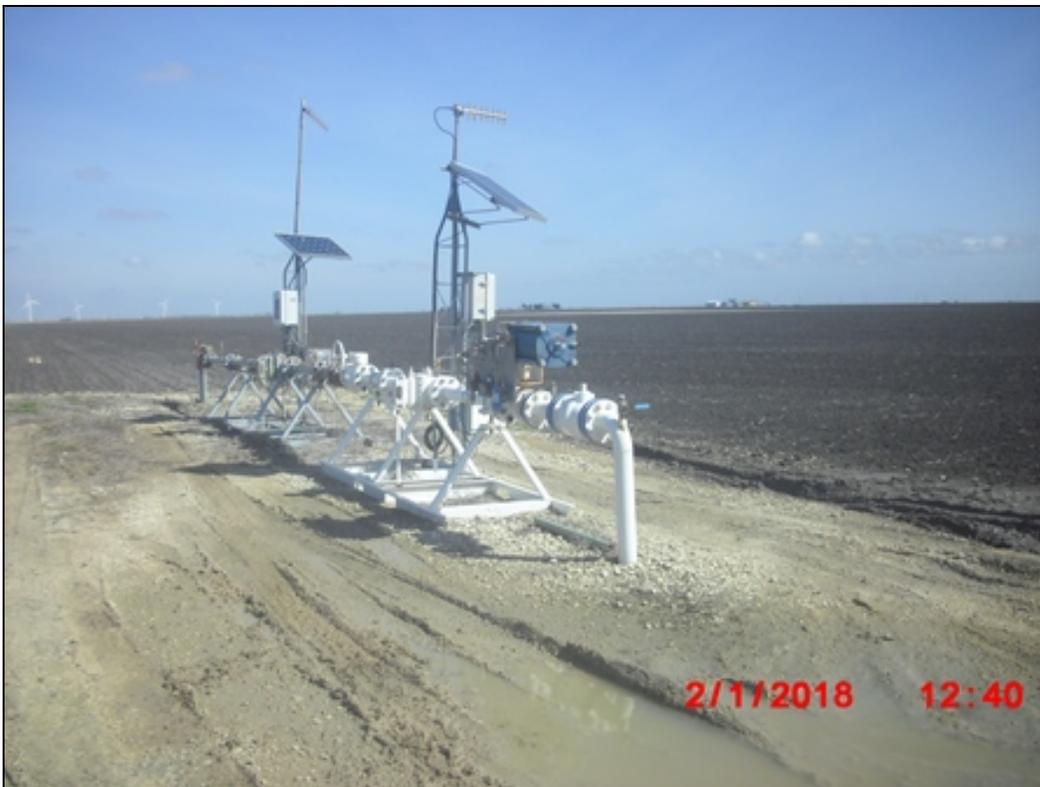
16. Photo taken near center of eastern property boundary facing northeast. An aboveground pipeline appurtenance adjacent to the subject property can be seen.

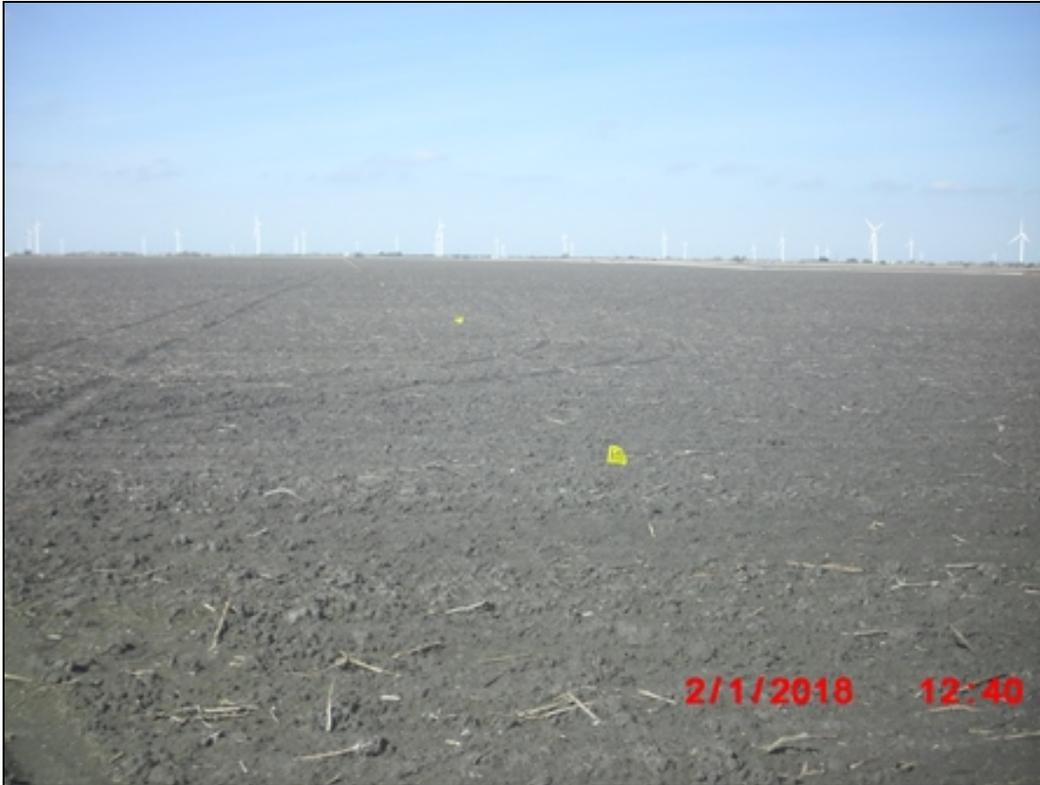
17. Photo taken near center of eastern property boundary facing northwest. Flag markers crossing the central portion of the subject property can be seen.

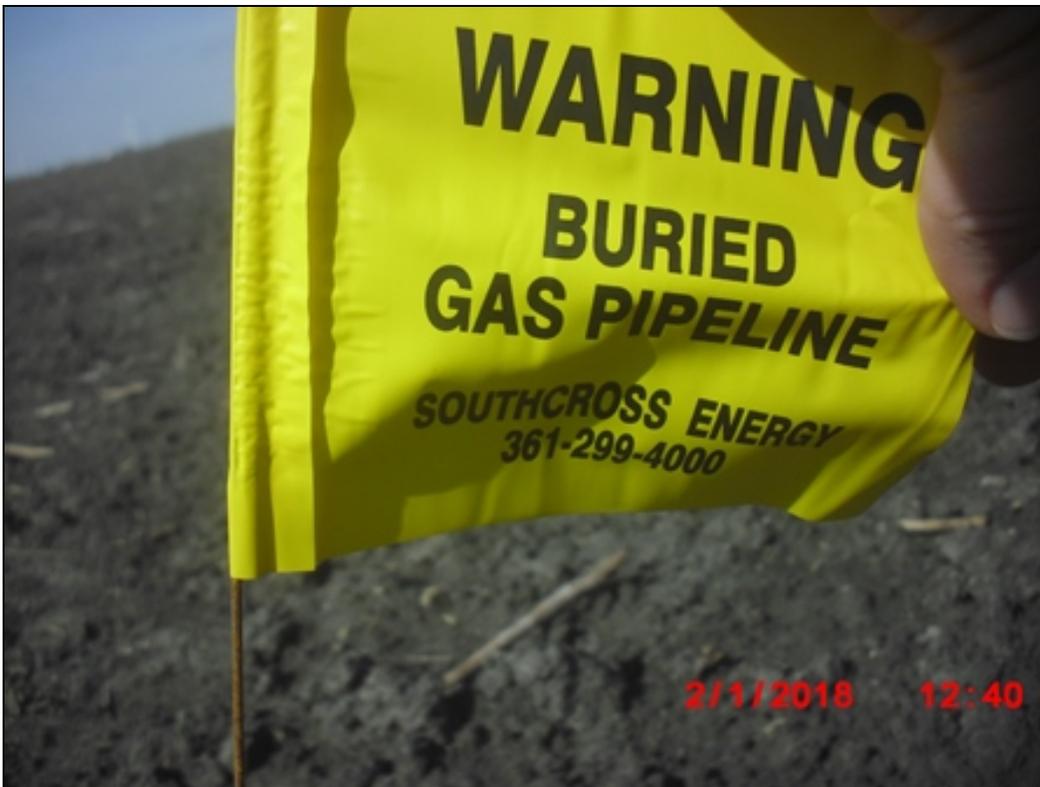
18. Photo taken near center of eastern property boundary. Warning flag from previous photo for a buried gas pipeline can be seen.

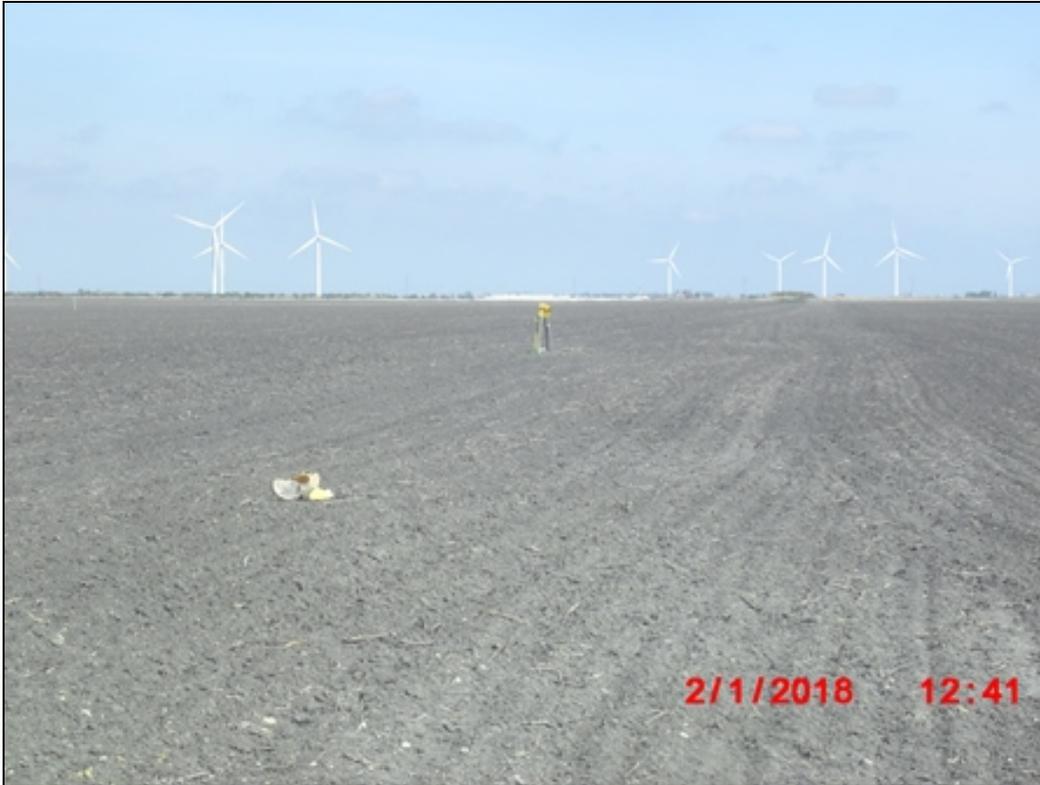
19. Photo taken near center of eastern property boundary facing northeast. In the distance, two pipeline warning markers can be seen. RRC records indicate that two in-service natural gas pipelines and one in-service nitrogen pipeline cross this portion of the subject property.

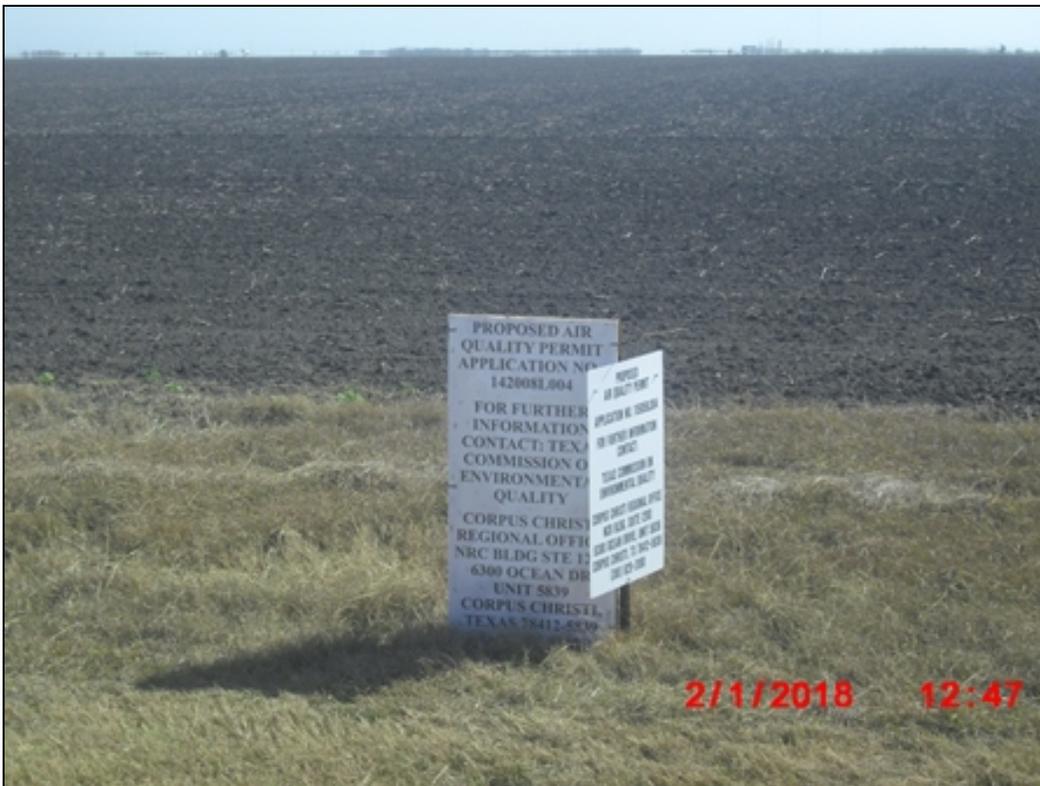
20. Photo taken approximately 7,450 feet north of southeast corner of subject property facing east. Two signs for proposed air permits (No. 142008L004 and 115956L004) for the property adjacent to the subject property can be seen. Both proposed permits are for operating concrete batch plants.

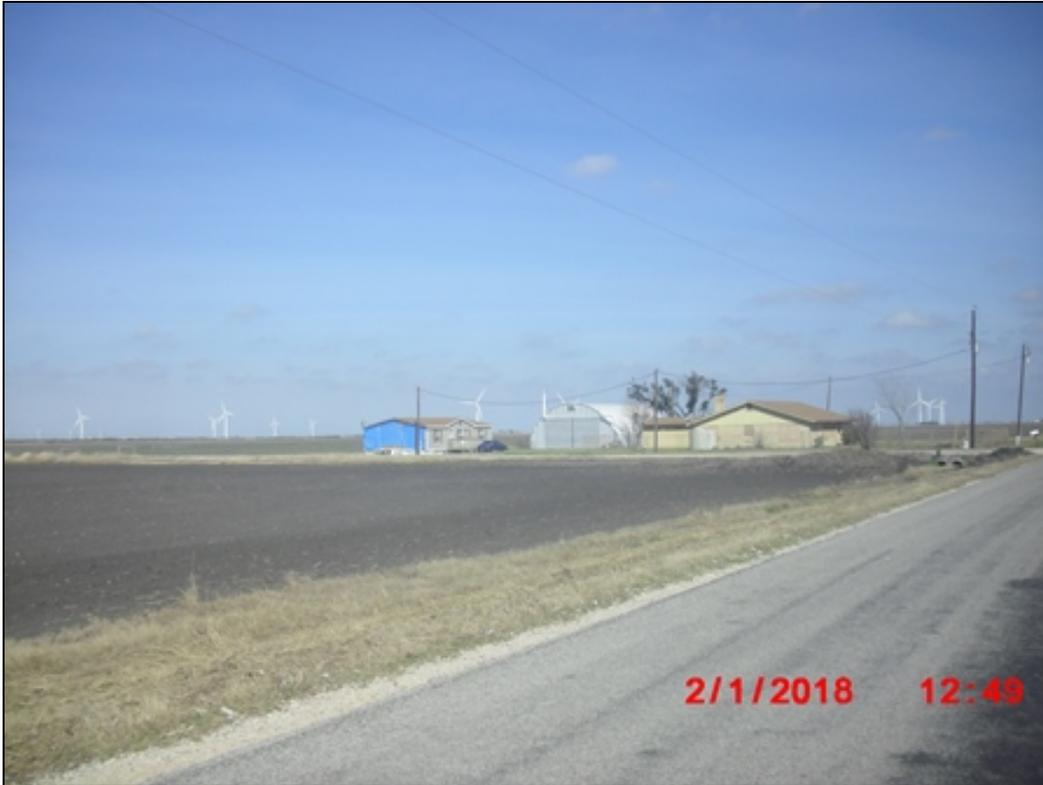
21. Photo taken approximately 7,450 feet north of southeast corner of subject property facing north. A residential property adjacent to the subject property can be seen.

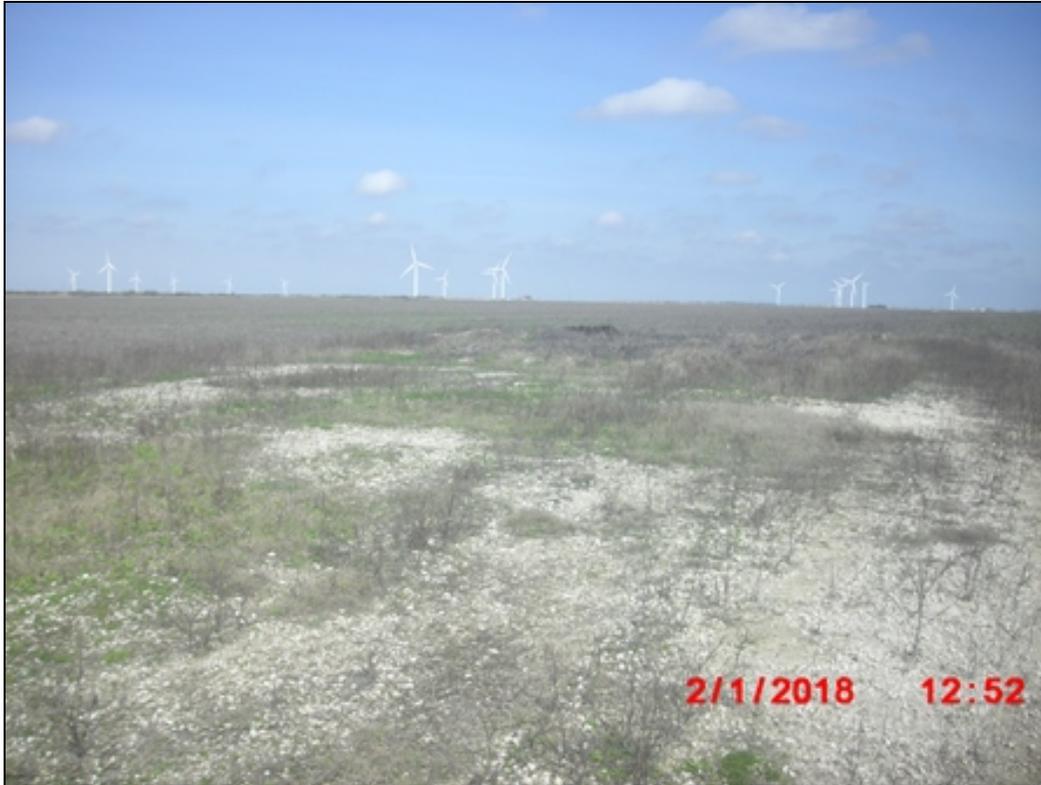
23. Photo taken along southern portion of northeast portion of subject property facing north. An old well pad can be seen on the subject property.

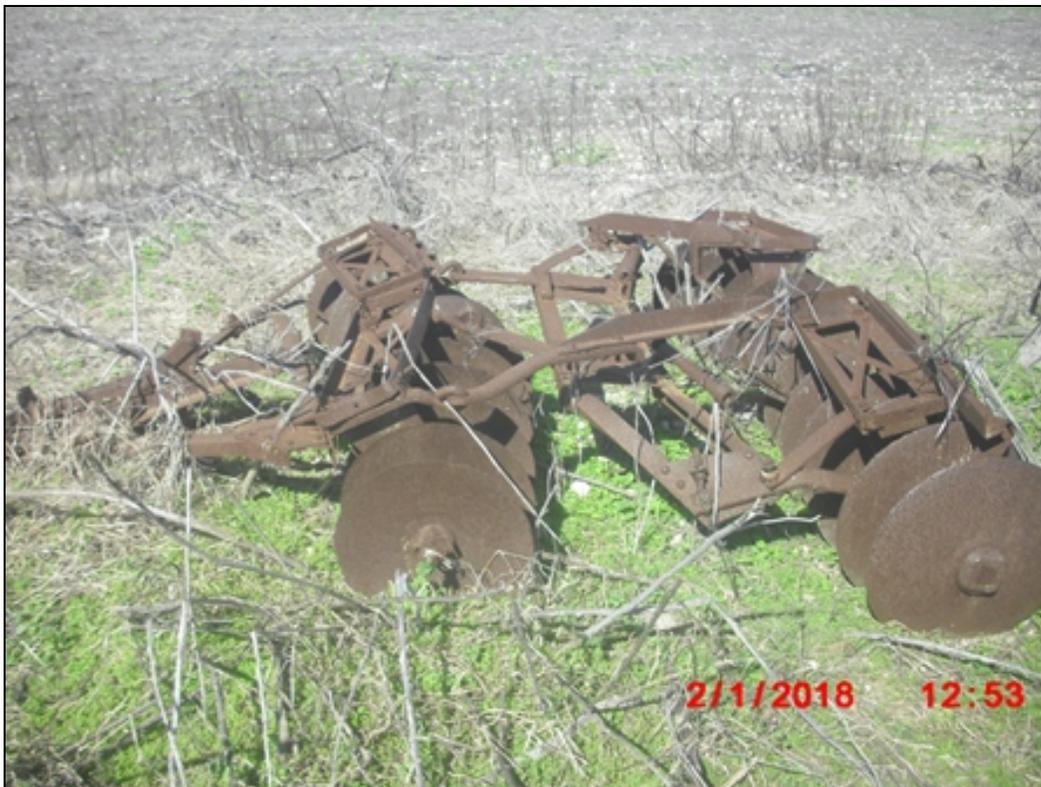
24. Photo taken along southern portion of northeast portion of subject property facing west. Abandoned farming equipment can be seen on the subject property.

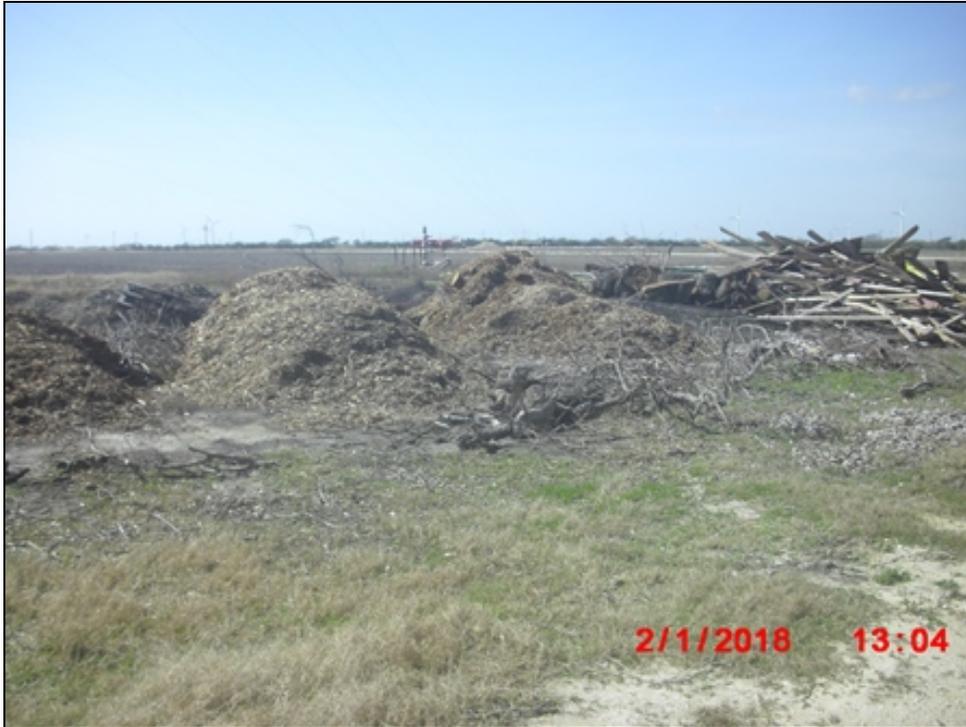
31. Photo taken in northeast portion of subject property facing southwest. Piles of brush, mulch, and lumber can be seen on the subject property.

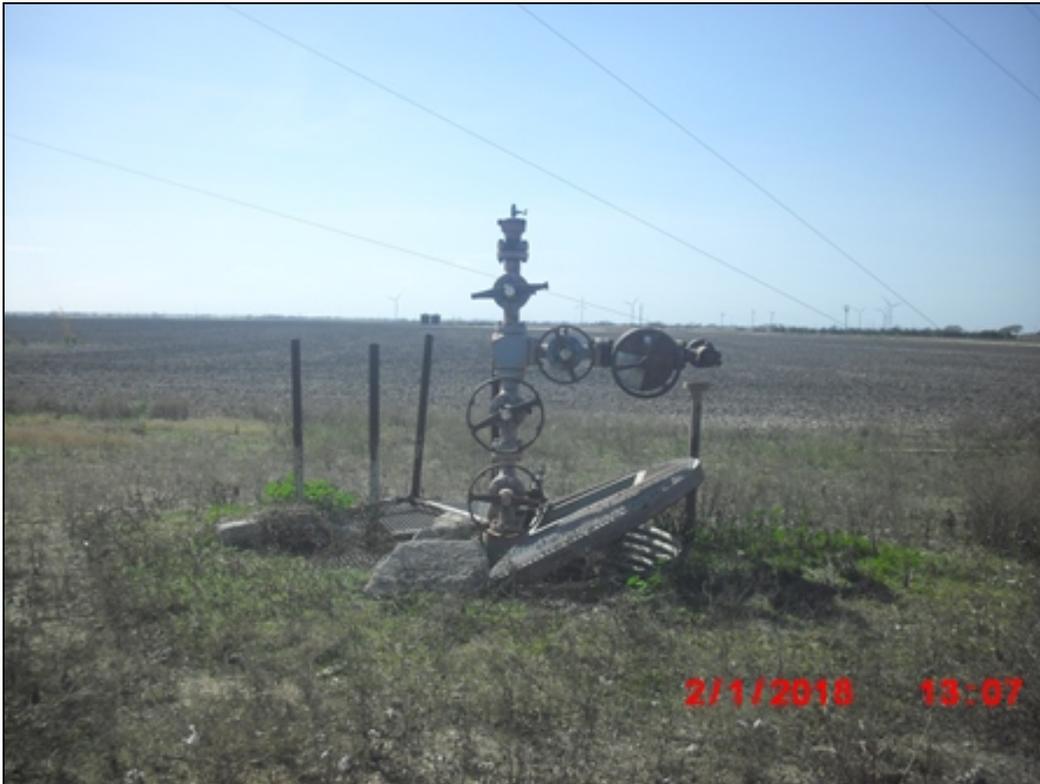
32. Photo taken in northeast portion of subject property facing southwest. A well surface tree can be seen on the subject property.

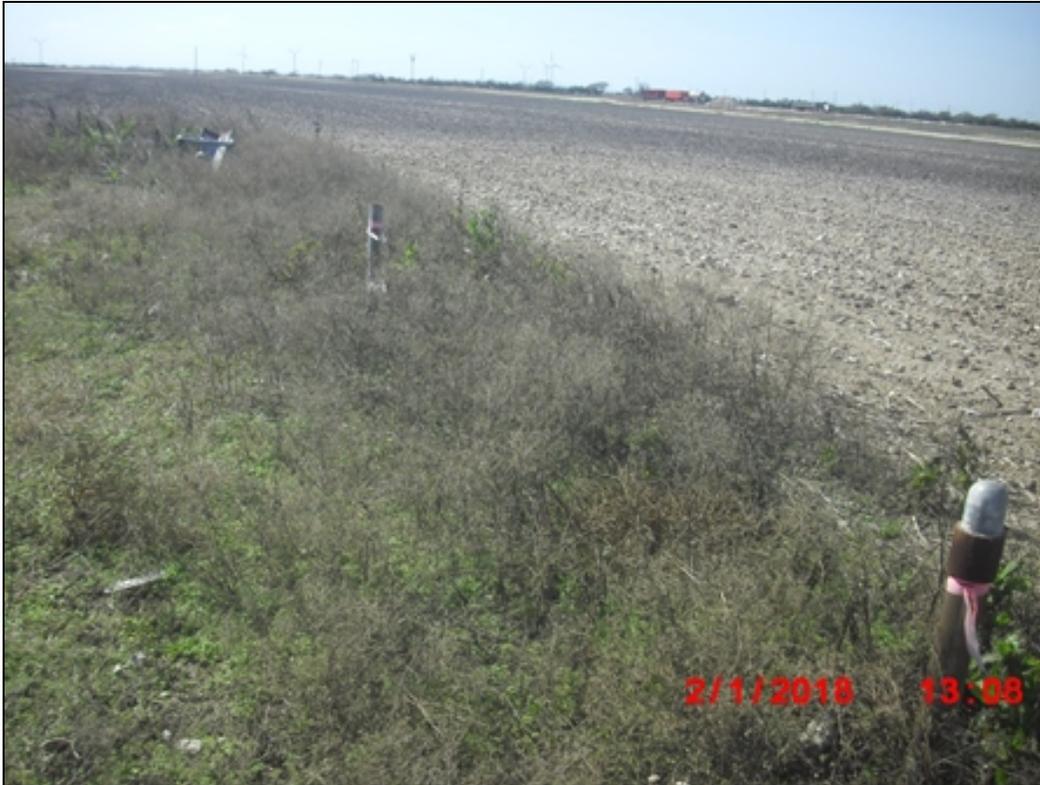
33. Photo taken to west of well surface tree facing southwest. Pipes protruding from the ground can be seen on the subject property.

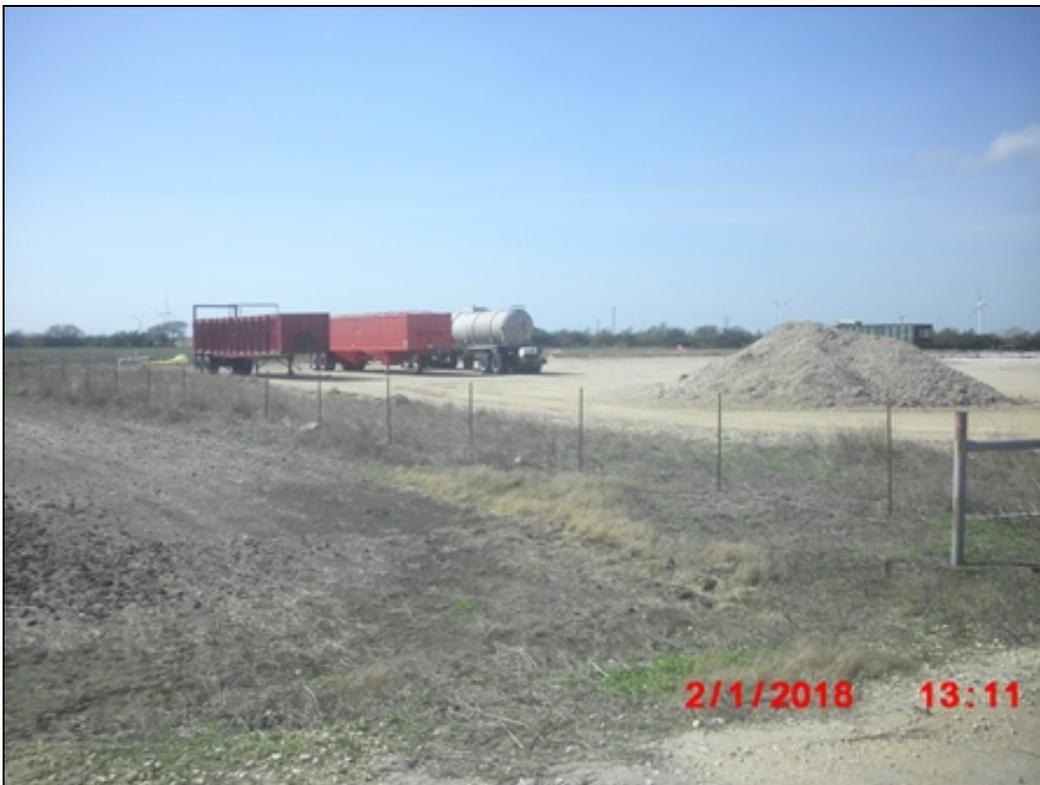
34. Photo taken in central portion of subject property facing southwest. A pad area possibly associated with past oil and gas exploration that is being used as a laydown area for harvested cotton and trailers can be seen.
