Phase I Environmental Site Assessment – McKamey Site Gregory, San Patricio County, Texas

February 2018

Prepared for Corpus Christi Regional Economic Development Corporation

Hanson Professional Services Inc. Project No. 18L0013 Task 1000

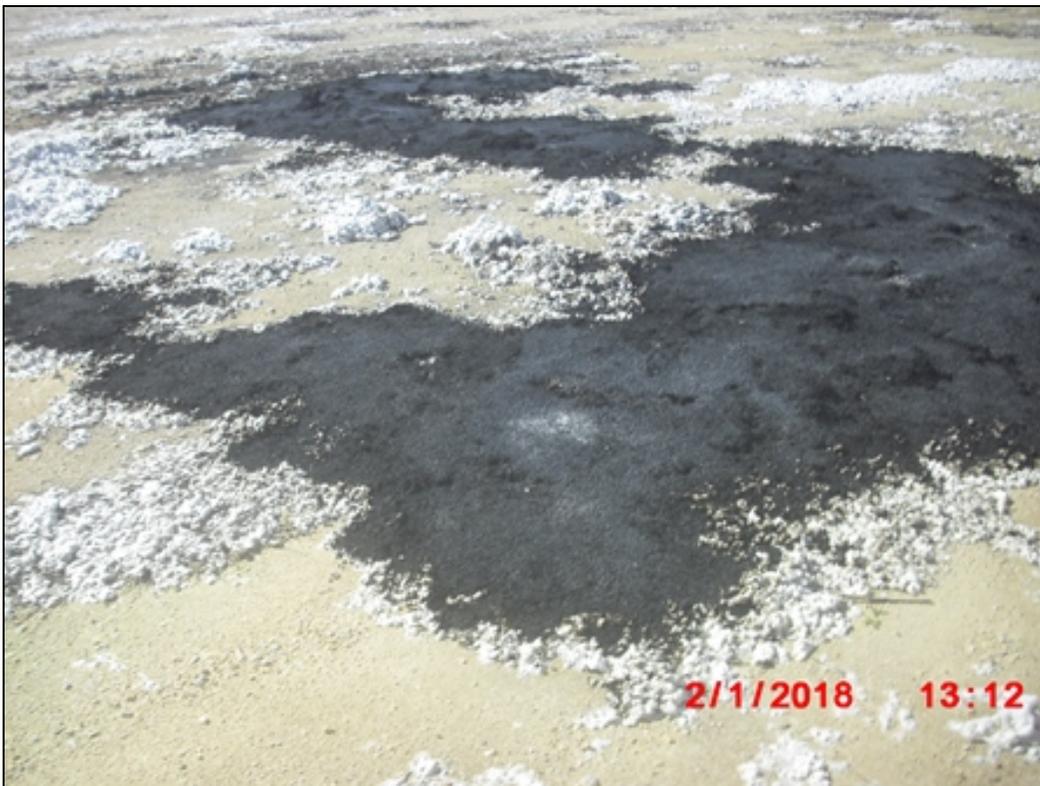
36. Photo taken in central portion of subject property on pad area. Harvested cotton appeared to have been burned on this pad as well as many others.

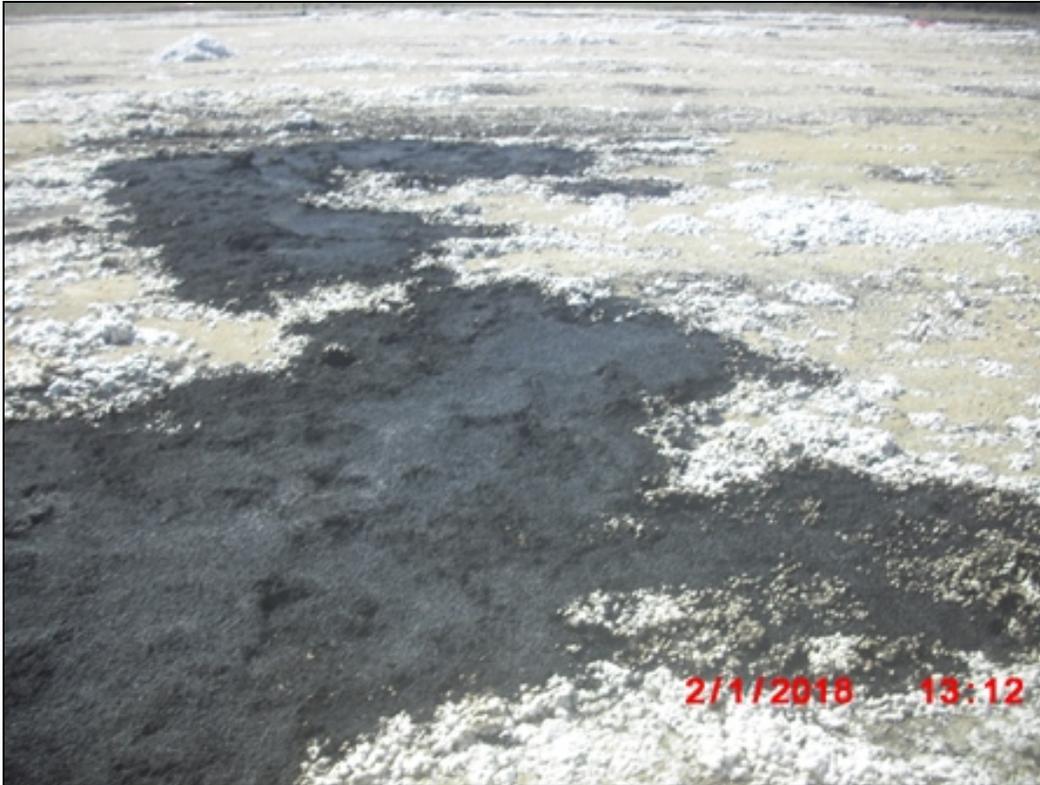
37. Photo taken in central portion of subject property on pad area. Harvested cotton appeared to have been burned on this pad as well as many others.

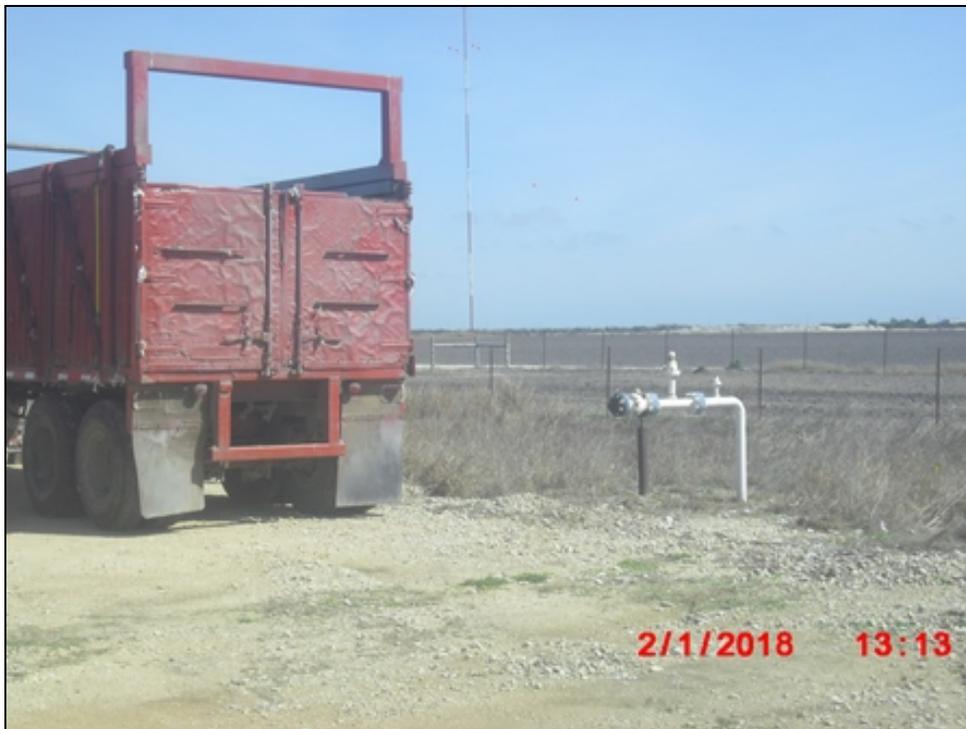
38. Photo taken in central portion of subject property on pad area. A pipe connection can be seen protruding from the ground.

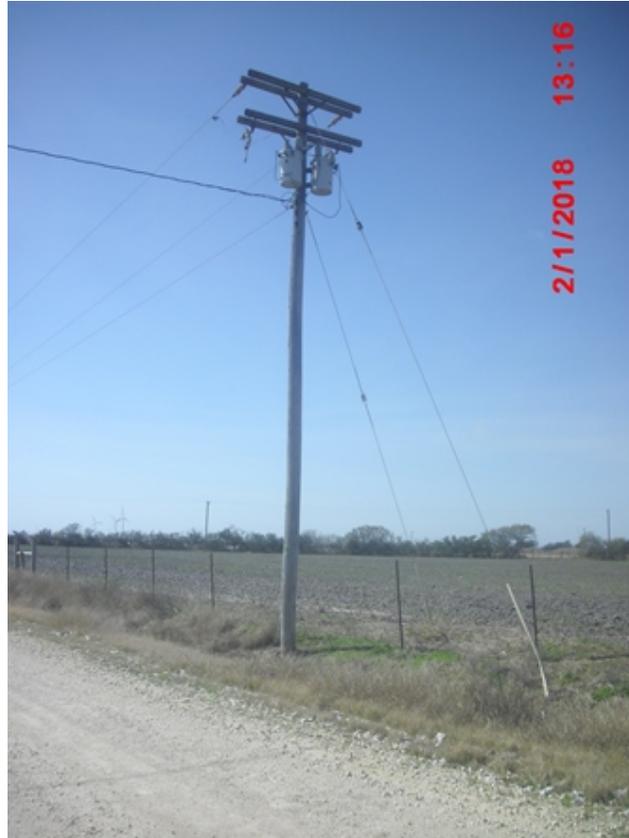
39. Photo taken in central portion of subject property facing southwest. Two pole-mounted transformers can be seen on the subject property. The transformers did not appear to have markings indicating that they were free of PCBs.

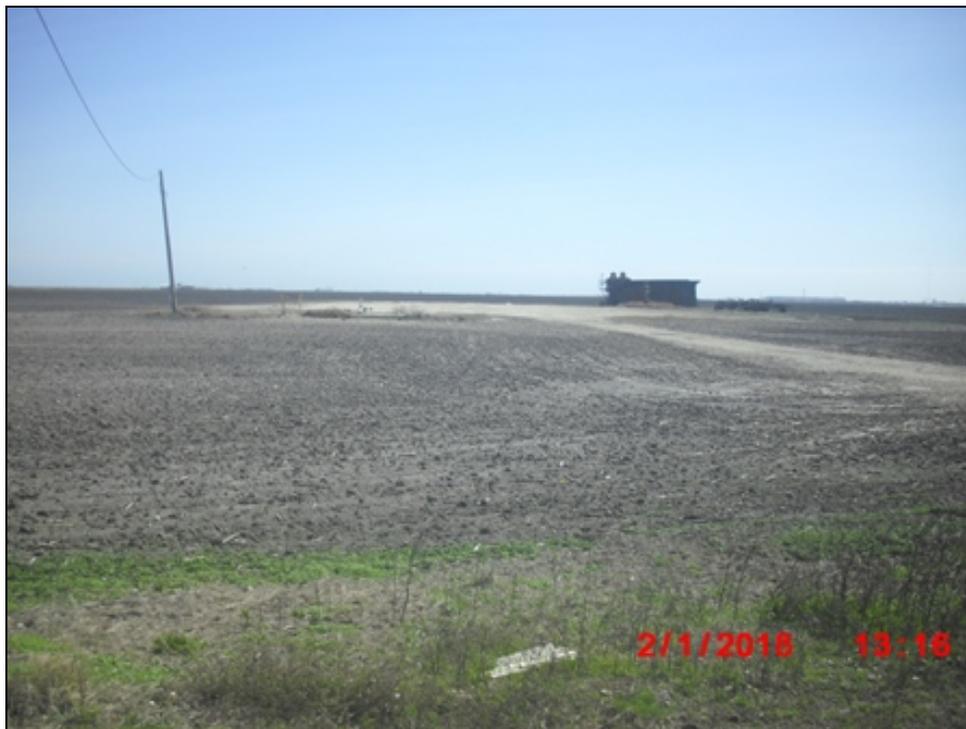
40. Photo taken in central portion of subject property facing southeast. A pad area possibly associated with past oil and gas exploration that is being used as a laydown area for two tanks and an aboveground pipeline appurtenance can be seen on the subject property.

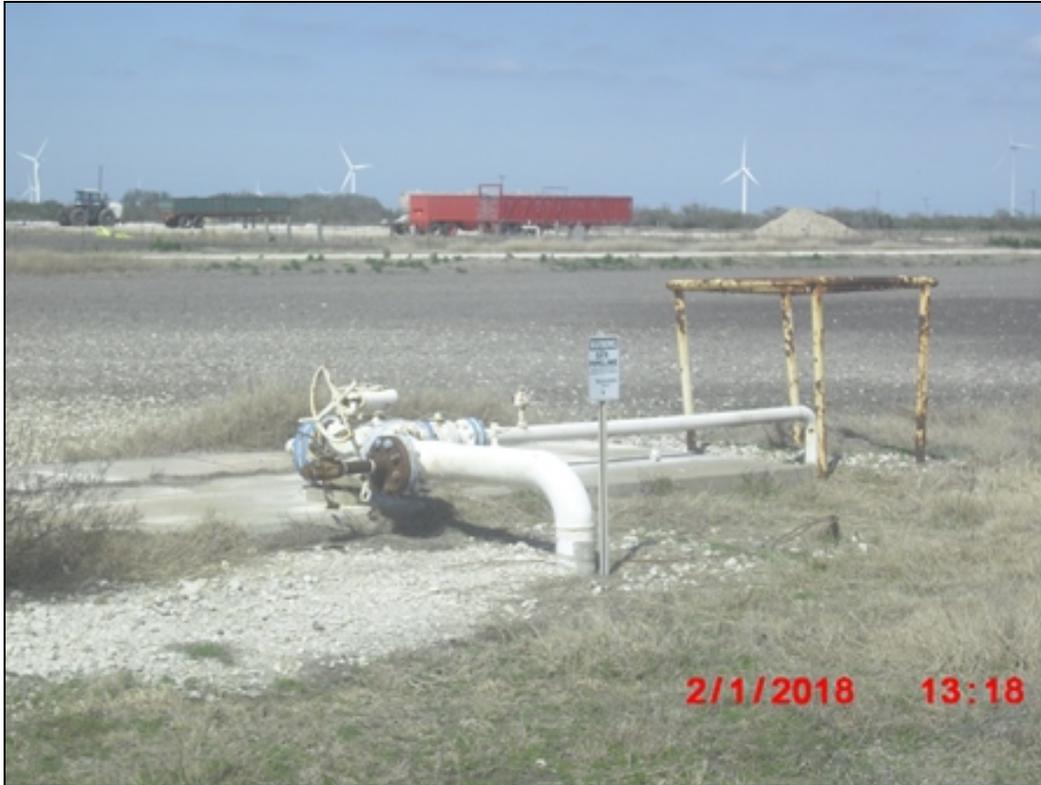
41. Photo taken in central portion of subject property facing northwest. A pipeline warning marker and an aboveground pipeline appurtenance can be seen on the subject property.

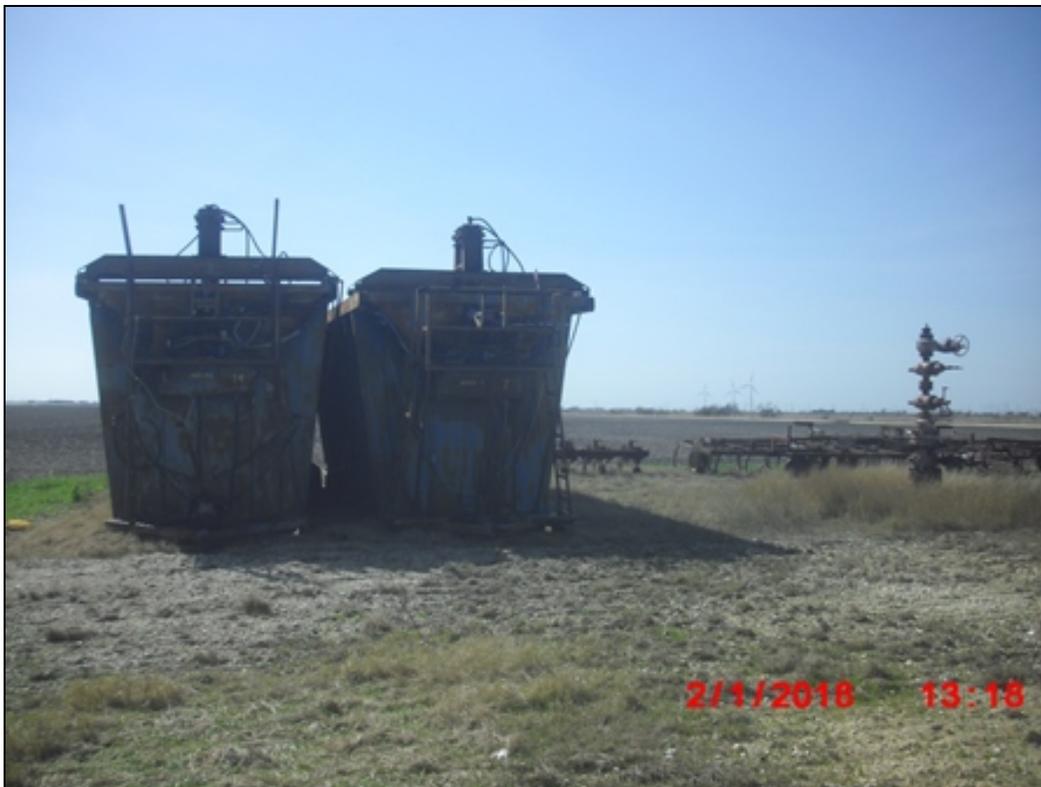
42. Photo taken in central portion of subject property facing southwest. Two tanks, a well surface tree, and farming equipment can be seen on the subject property.

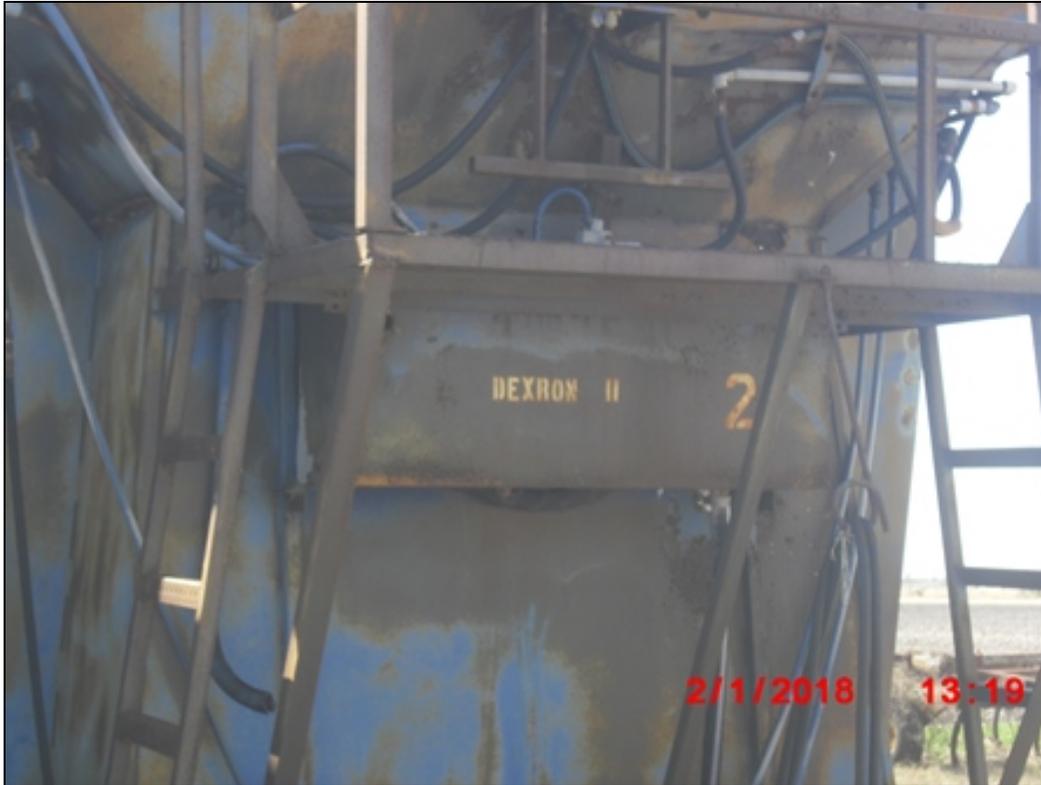
43. Photo of label on tanks in previous photo. Dexron II was an automatic transmission fluid used in the 1970s.

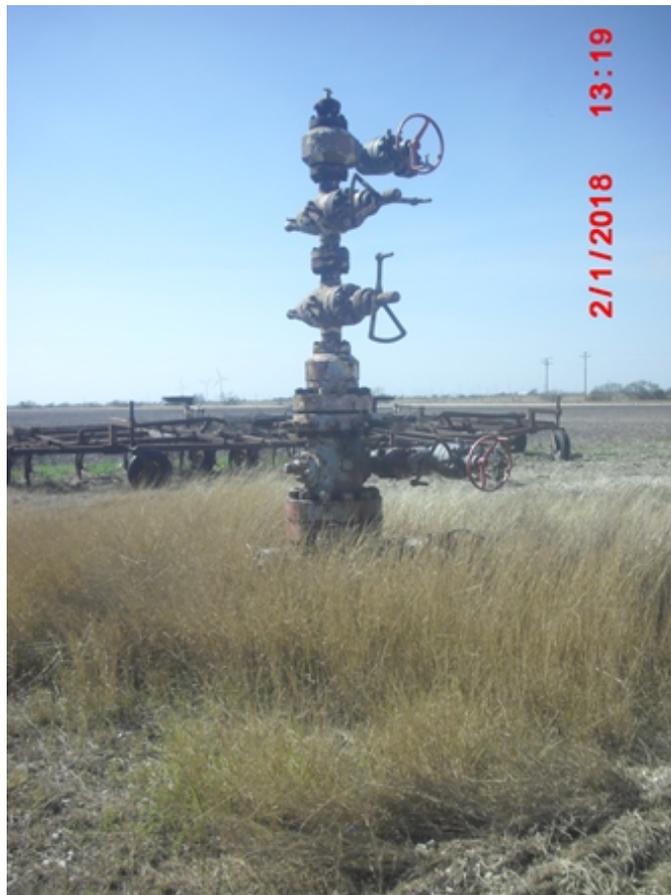
44. Photo of well surface tree from photo #42.

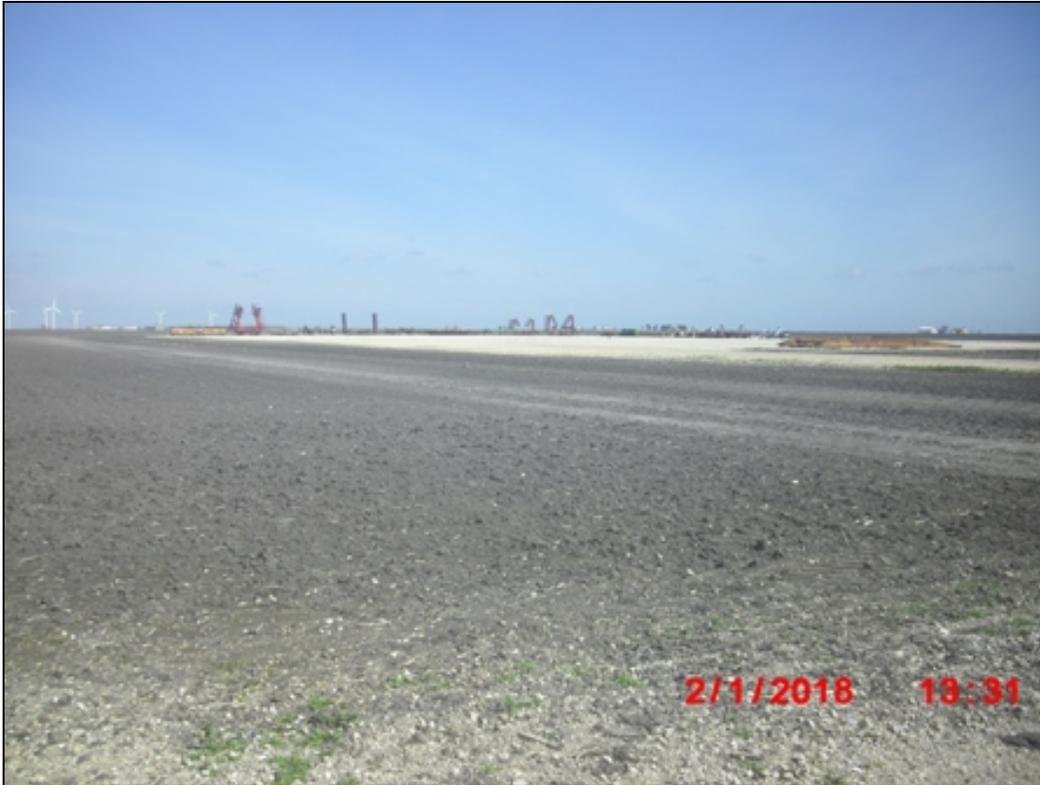
51. Photo taken in central portion of subject property facing southeast. A pad area possibly associated with past oil and gas exploration that is being used as a laydown area for farming equipment can be seen on the subject property.

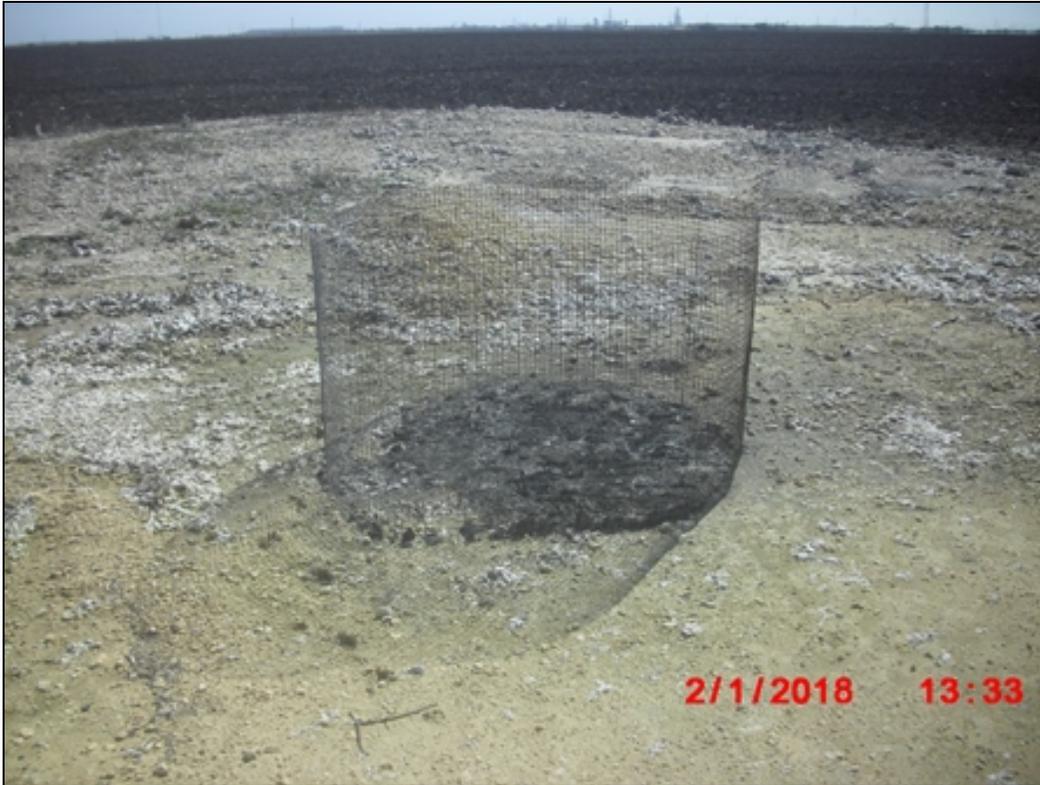
53. Photo taken on pad area in central portion of subject property facing southeast. A caged area that appeared to be used for burning material can be seen.

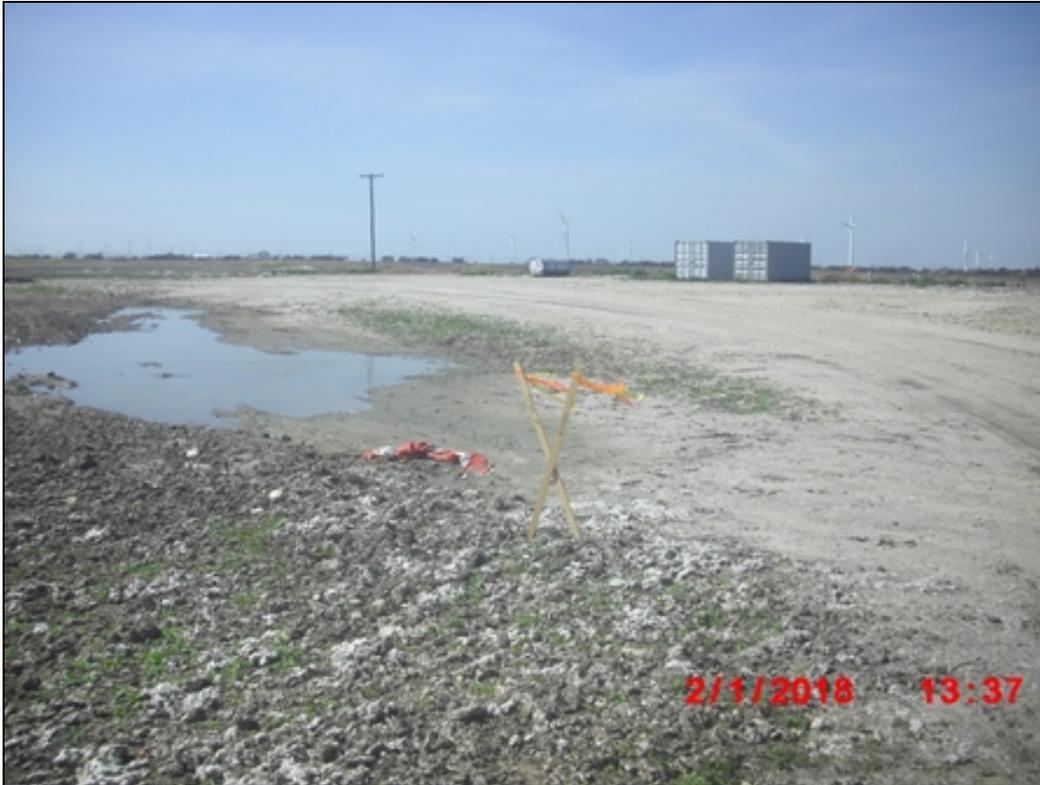
55. Photo taken in central portion of subject property facing southwest. A pad area possibly associated with past oil and gas exploration that is being used as a laydown area for two storage units, a fuel tank, and two herbicide tanks can be seen.

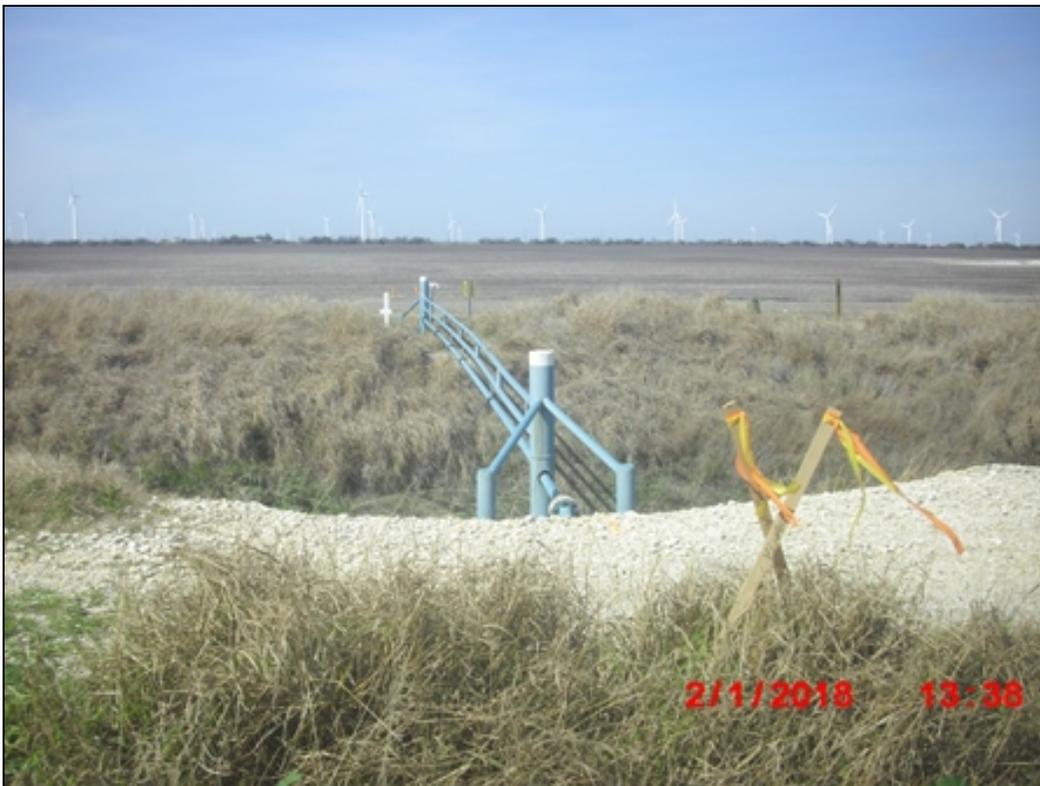
56. Photo taken on pad area facing west. A natural gas pipeline crossing a ditch on the subject property can be seen.

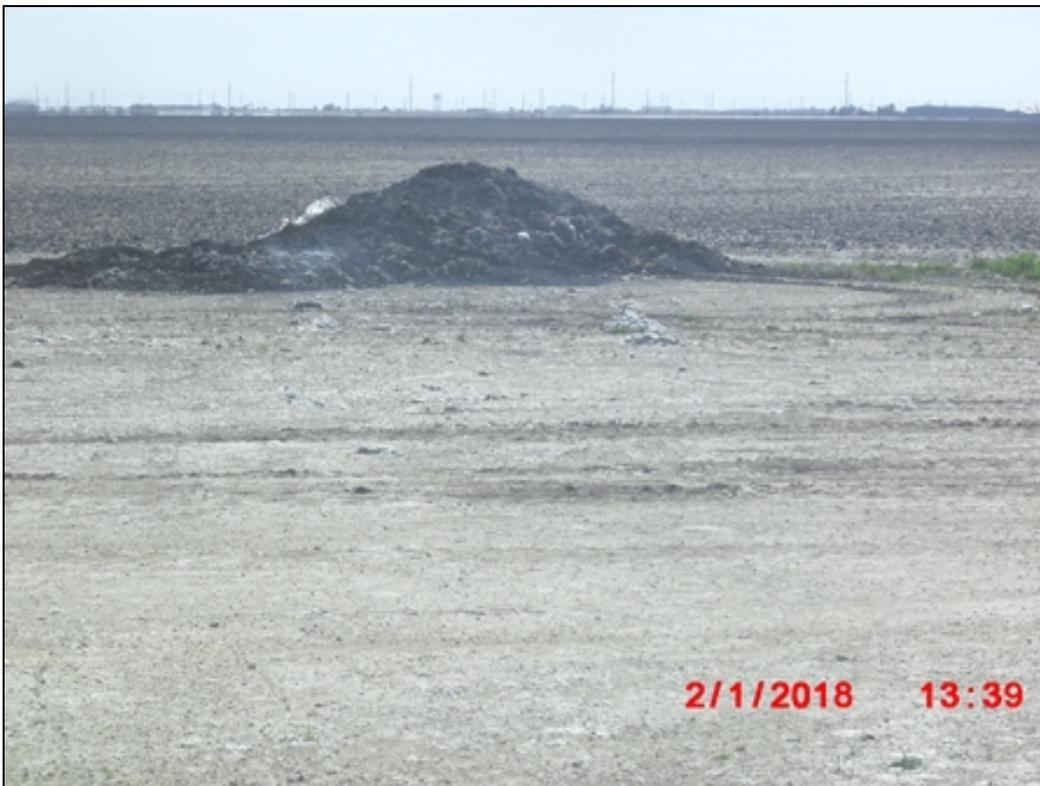
Piles of harvested cotton were being burned on two locations on the subject property during the site visit. Many other piles appeared to have been previously burned. Piles of brush, mulch, and lumber were observed in the north central portion of the subject property. To the north of the subject property, an area was observed where illegal dumping of household items such as furniture and children's toys had occurred.

58. Photo taken on pad area facing south. A pile of burning cotton on the subject property can be seen.

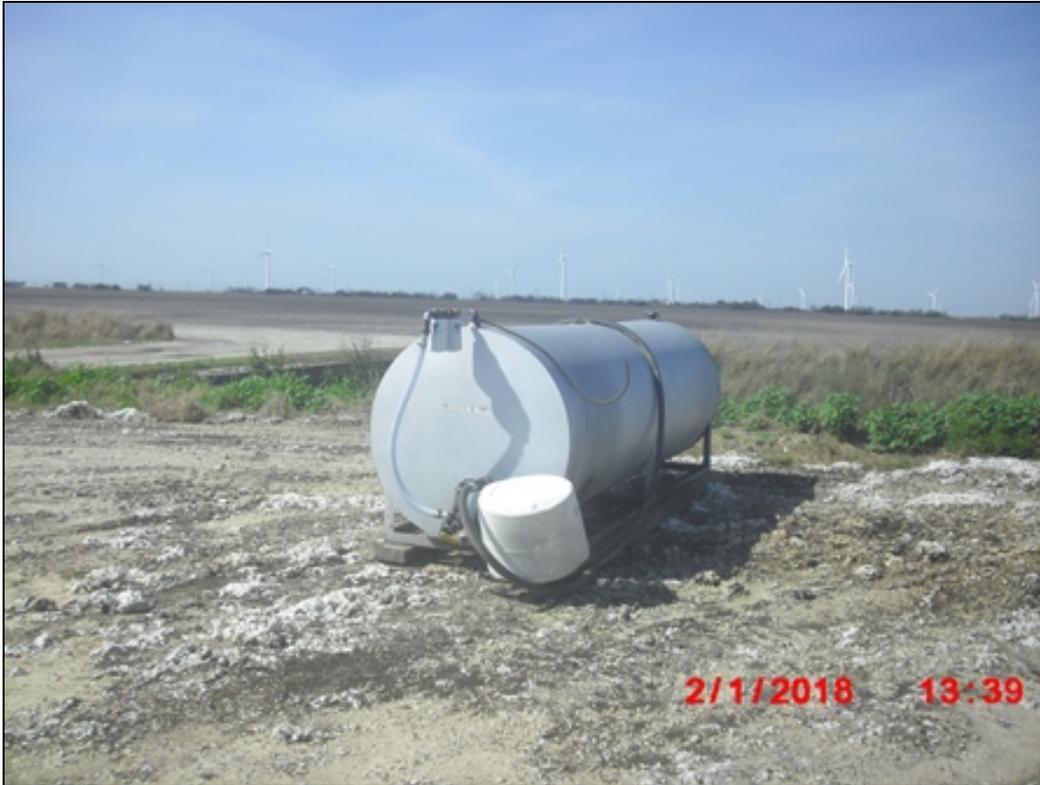
59. Photo taken on pad area facing west. A tank for storing tractor diesel can be seen on the subject property.

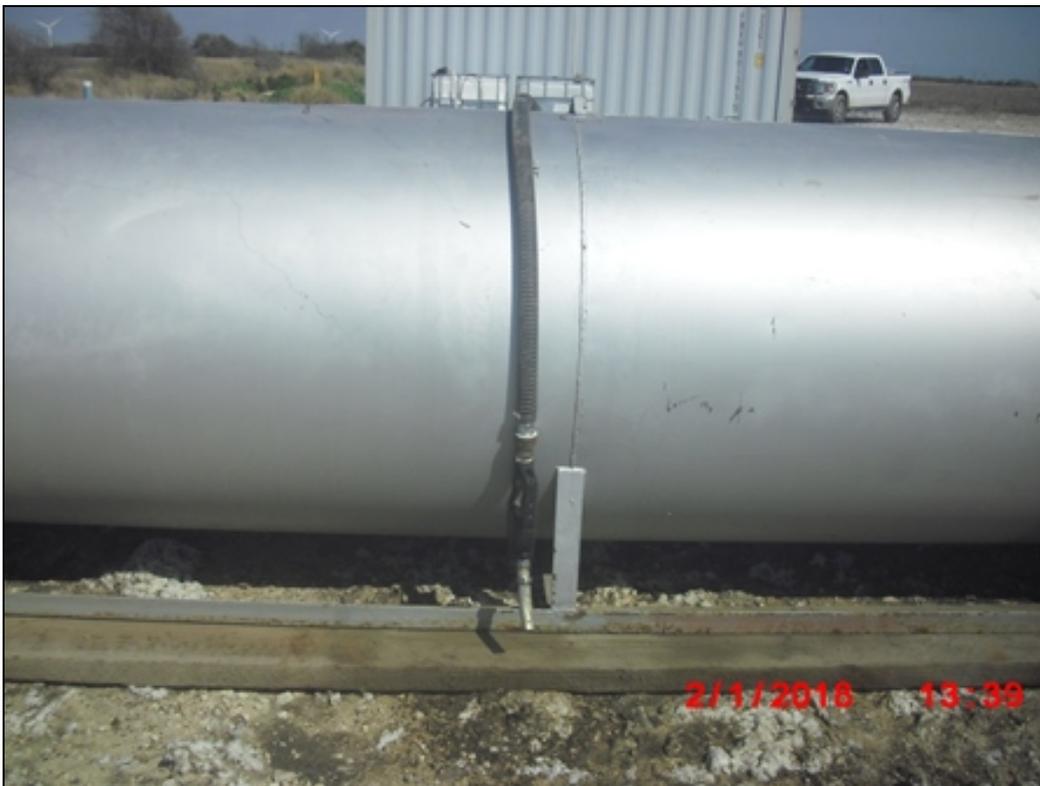
60. Photo taken on pad area facing north. A nozzle for the tractor diesel tank can be seen.

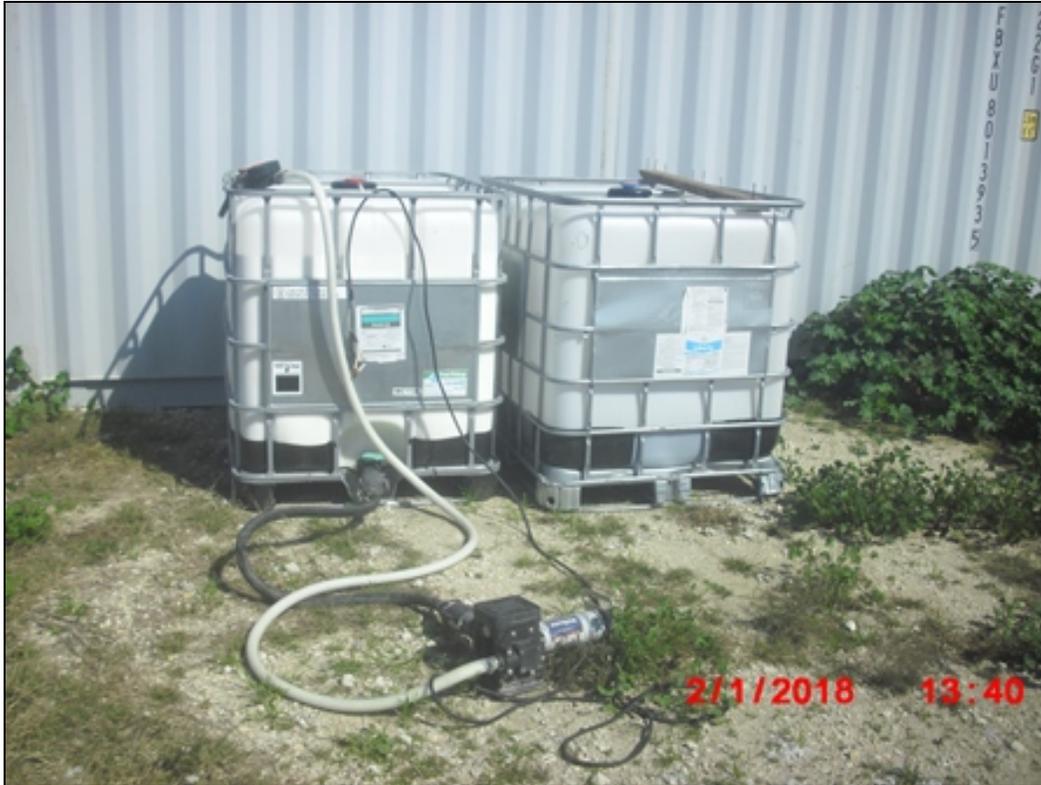
63. Photo taken on pad area facing north. Two tanks for storing herbicides can be seen on the subject property.

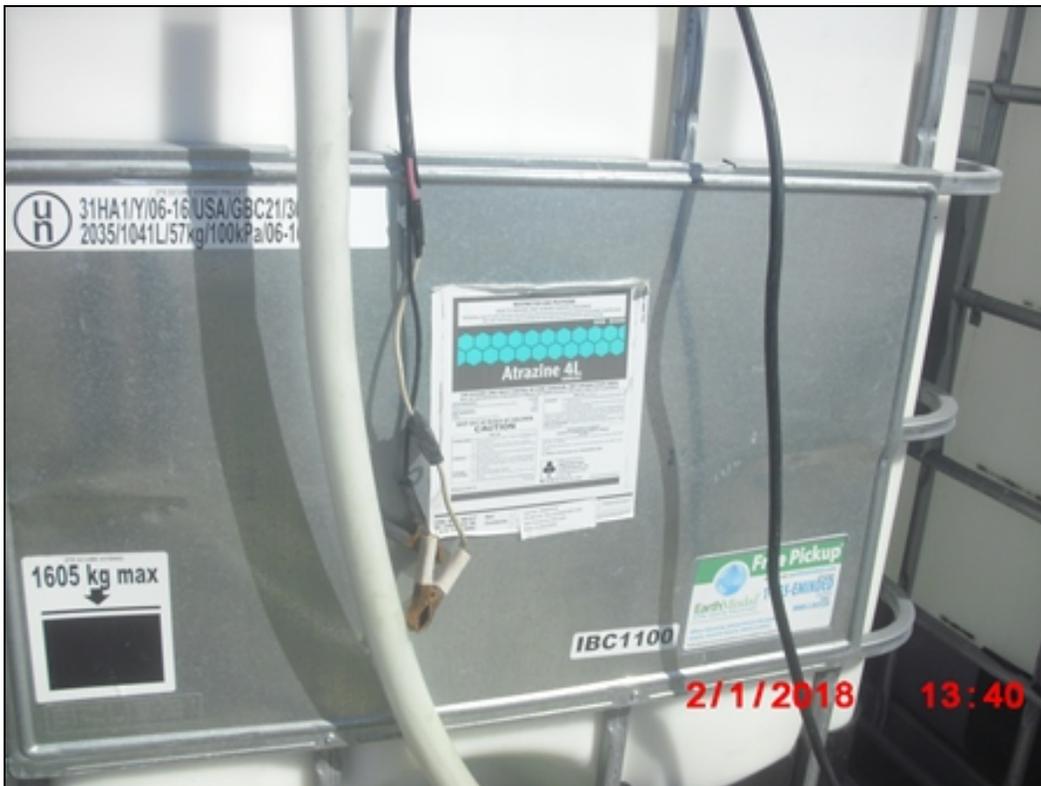
64. Photo of tank labeled to contain Atrazine 4L herbicide.

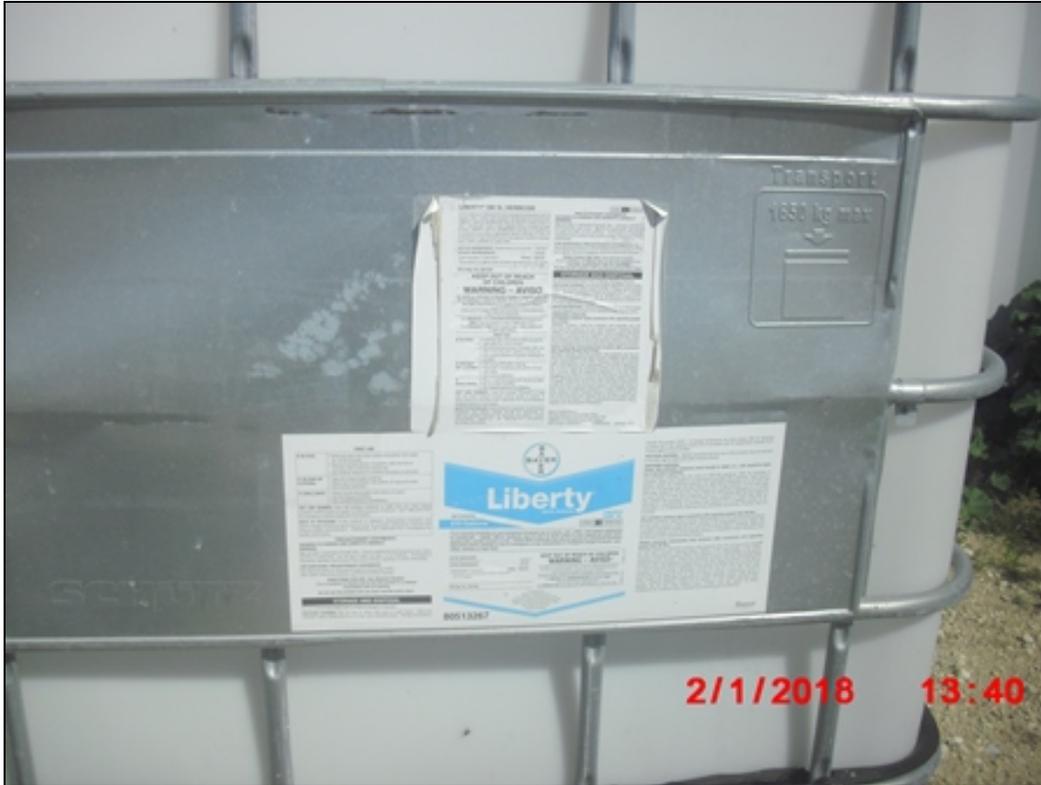
65. Photo of tank labeled to contain Liberty 280 SL herbicide.

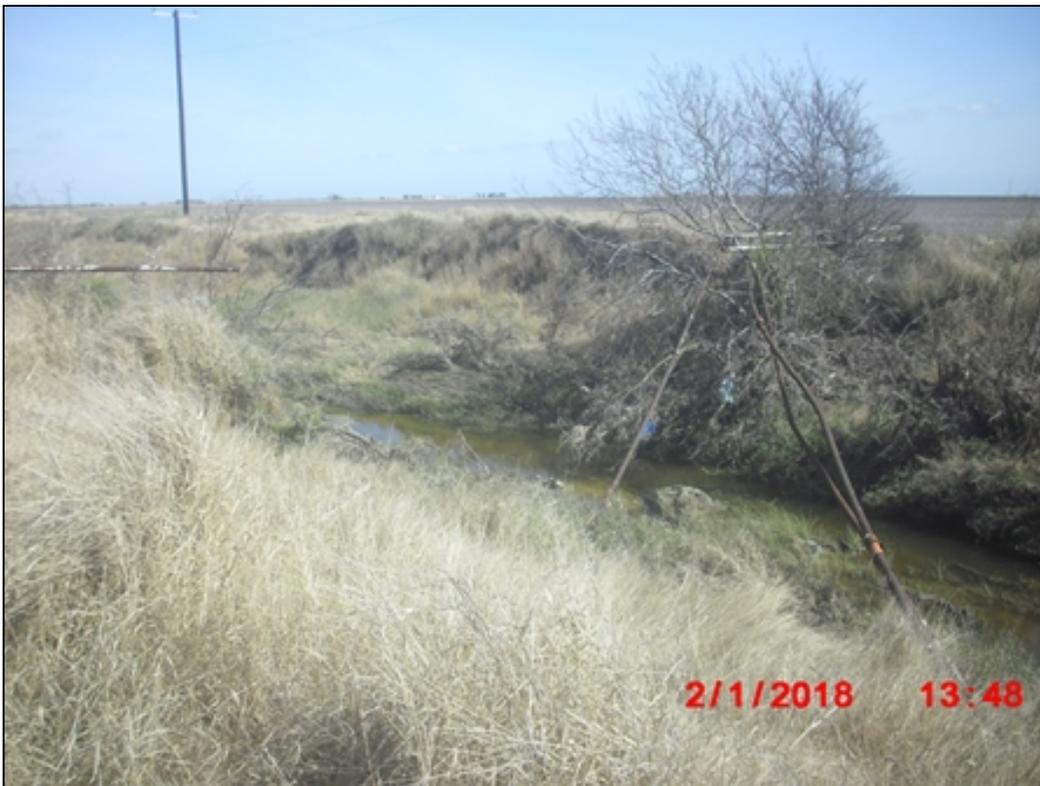
68. Photo taken on southern portion of the private road that crosses north/south through the subject property facing northeast. A pipeline that used to cross the ditch on the subject property appears to have fallen down.

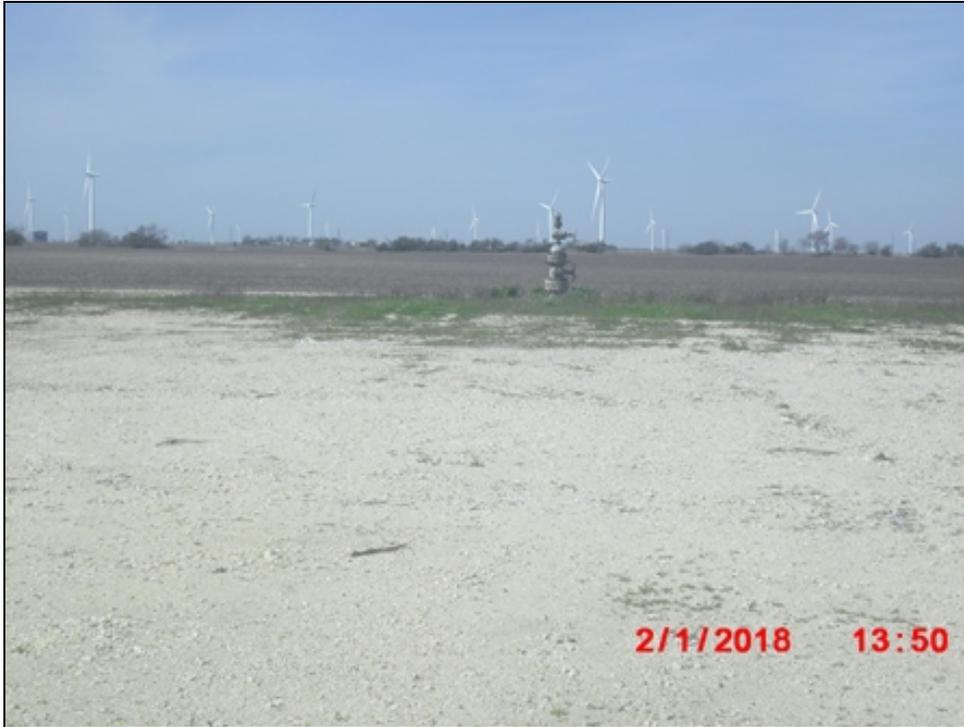
69. Photo taken on southern portion of the private road that crosses north/south through the subject property facing west. A well pad and well surface tree can be seen.

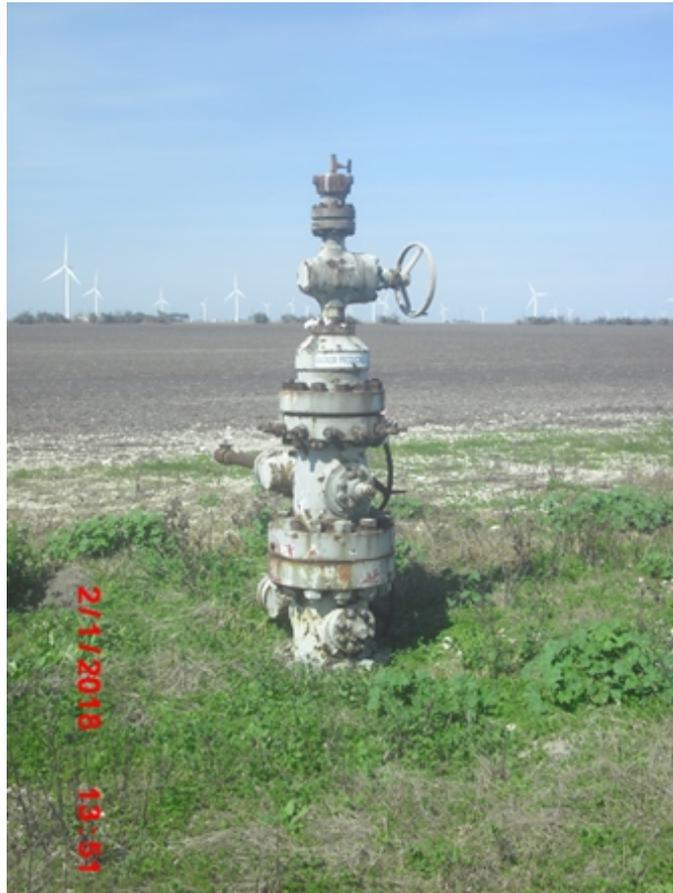
70. Photo of well surface tree from previous photo.

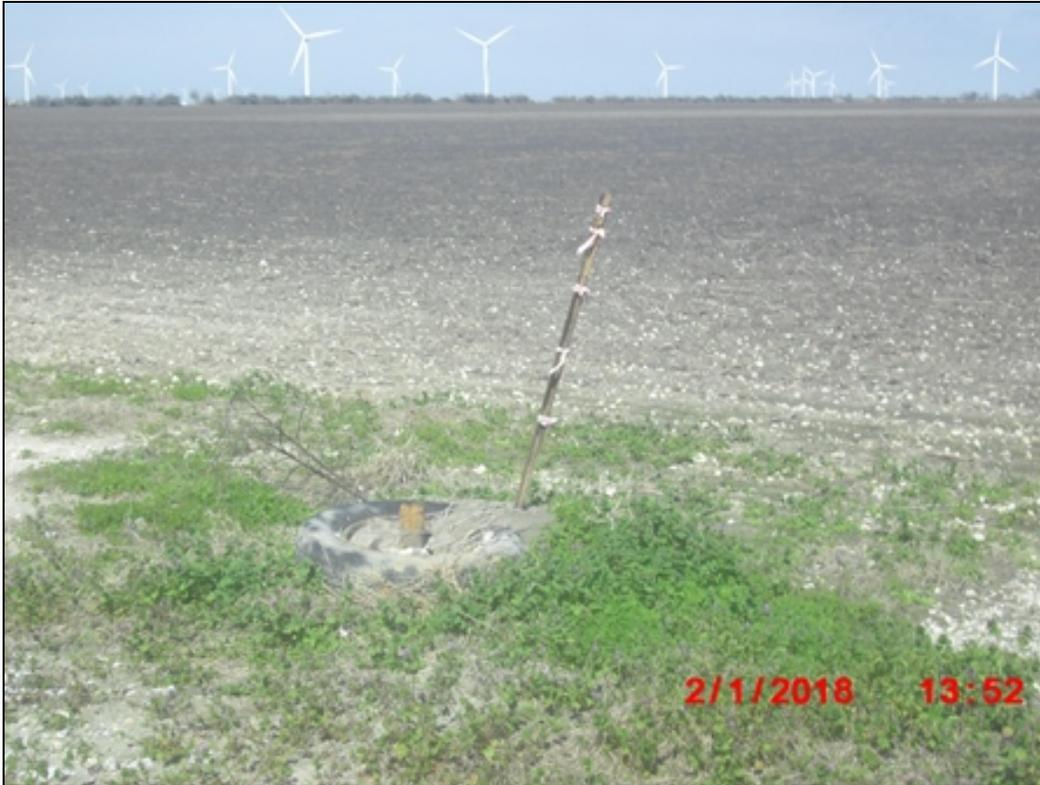
71. Photo taken on southern portion of the private road that crosses north/south through the subject property facing northwest. A tire and metal post can be seen on the subject property.

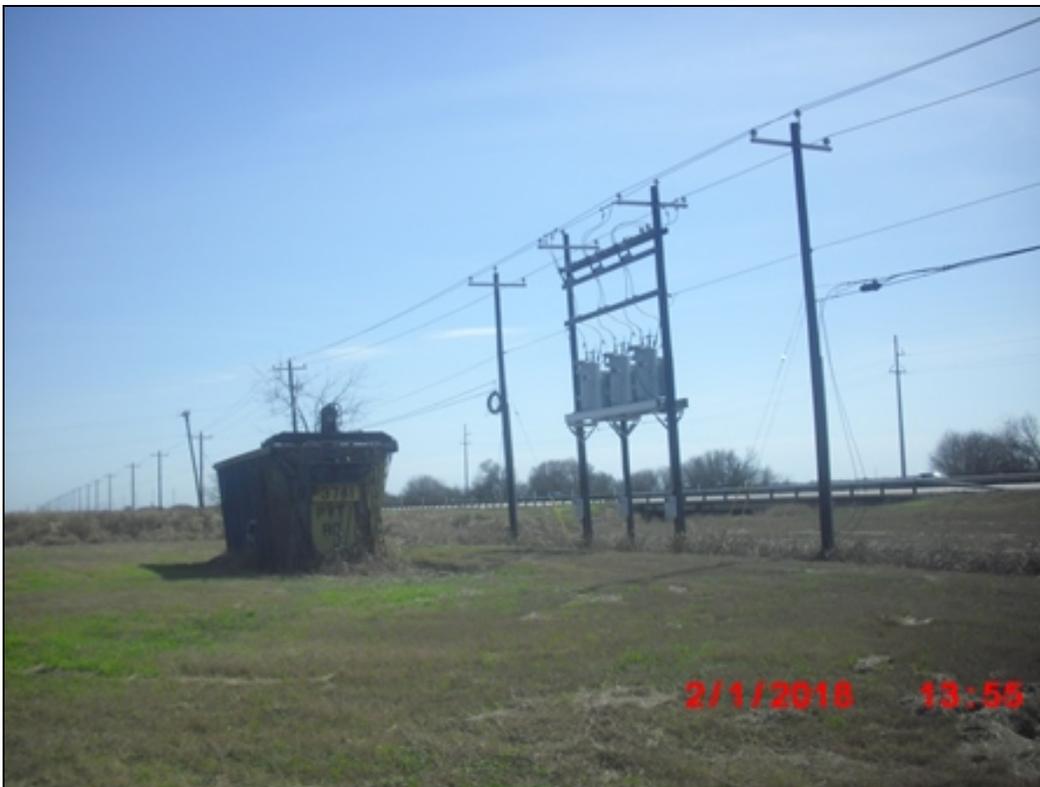
72. Photo taken on southern portion of the private road that crosses north/south through the subject property facing southeast. A tank and three elevated transformers can be seen.

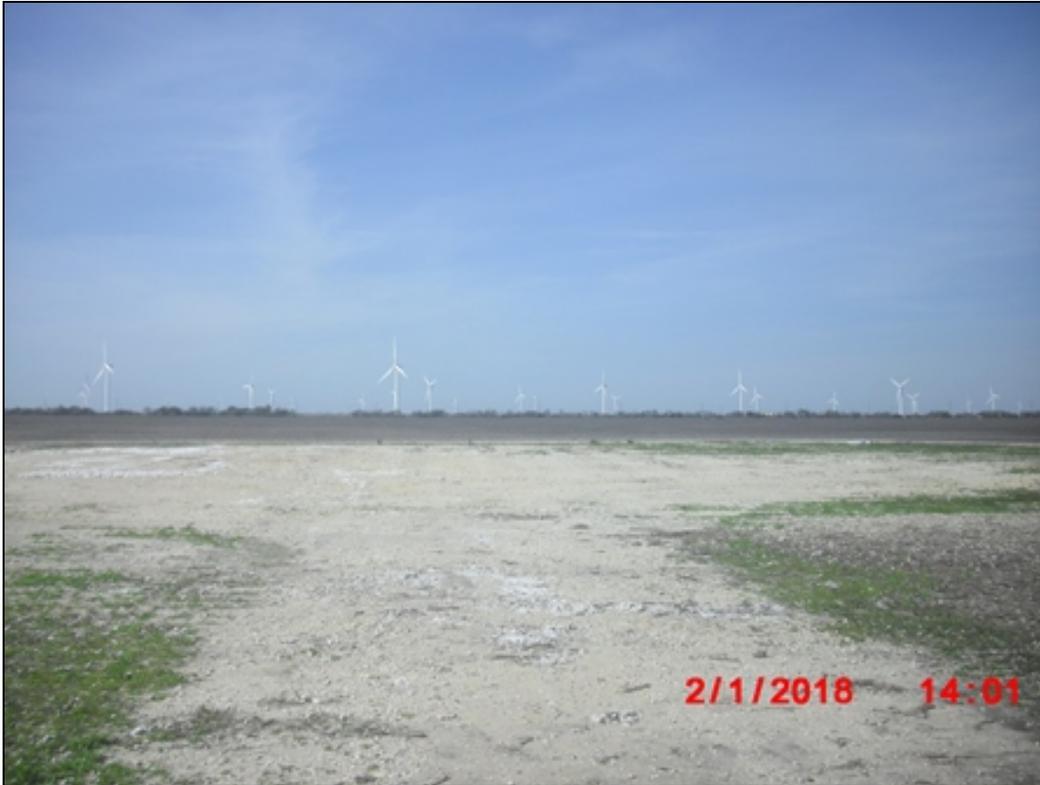
73. Photo taken on central portion of the private road that crosses north/south through the subject property facing west. A pad area possibly associated with past oil and gas exploration that is not currently being used can be seen.

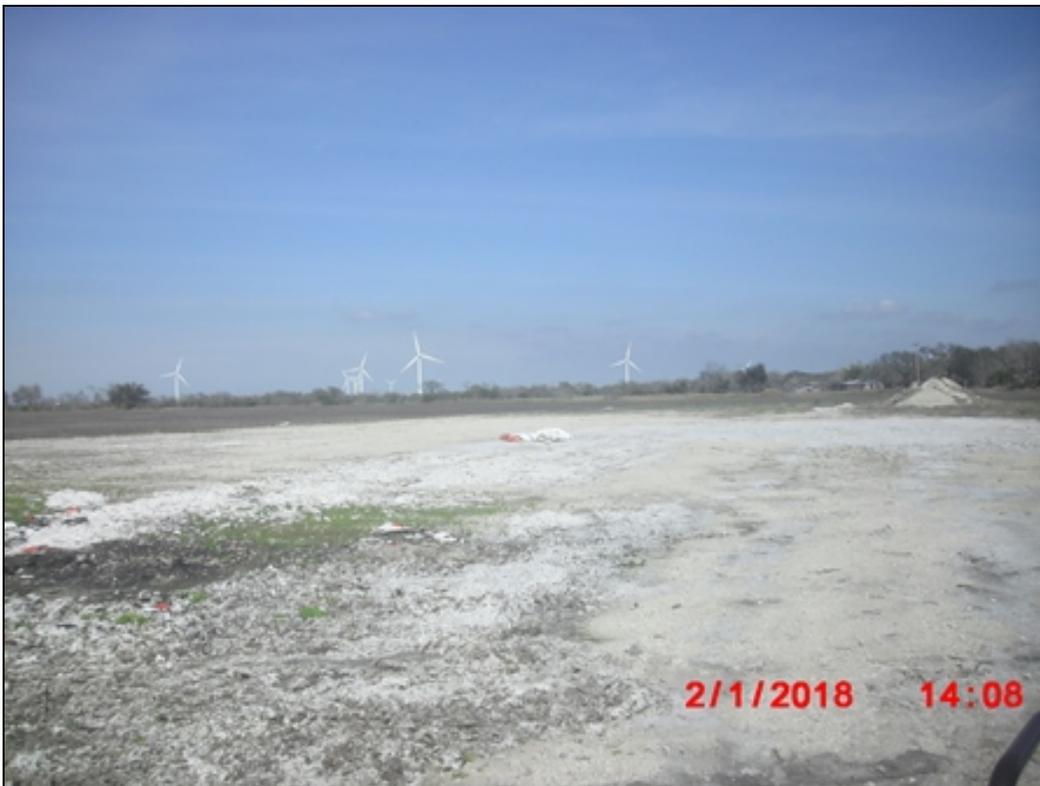
74. Photo taken in central portion of subject property facing north. A pad area possibly associated with past oil and gas exploration that is not currently being used can be seen.

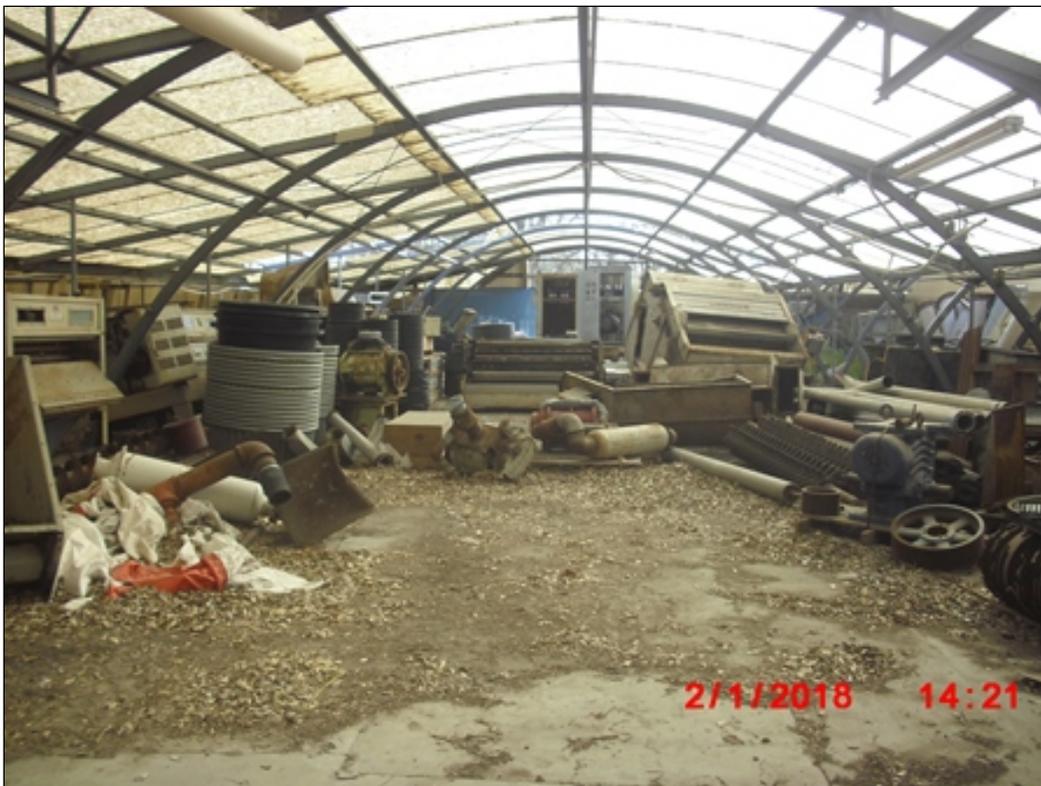
86. Photo of interior of building in previous photo. Several stacked plant containers and what appears to be cotton gin equipment can be seen.

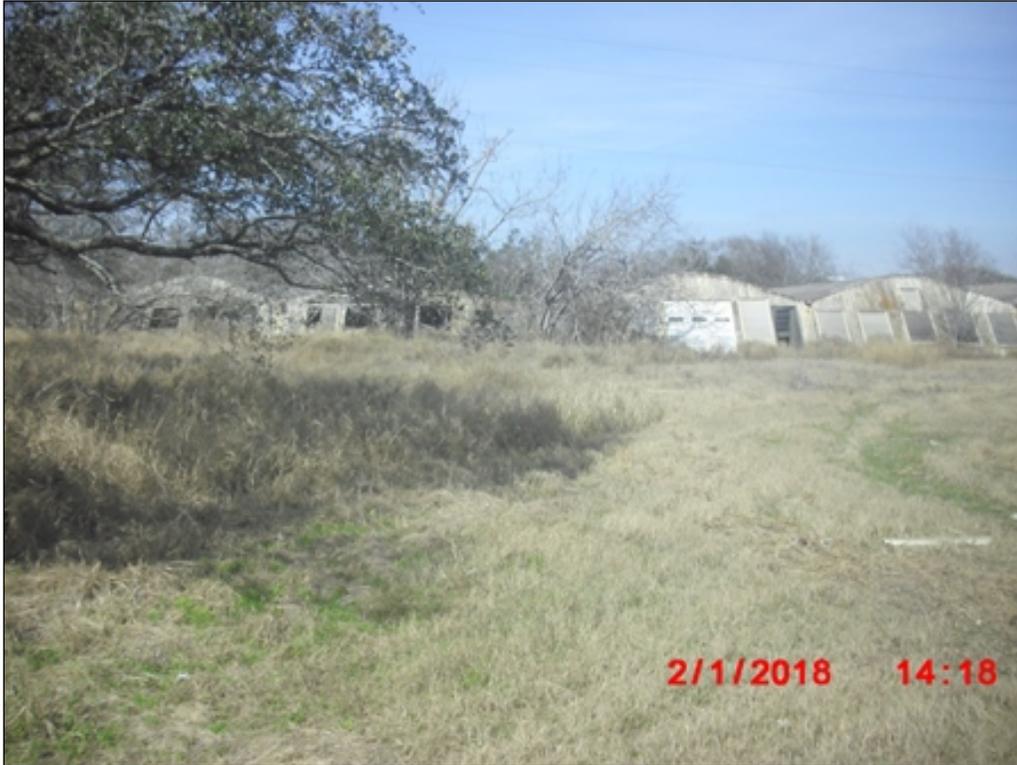
87. Photo taken in central portion of subject property facing northwest. The exterior of the building in the previous photo can be seen. The structure was previously used as a greenhouse operation but is now abandoned and appears to be leaning.
