Phase I Environmental Site Assessment – McKamey Site Gregory, San Patricio County, Texas

February 2018

Prepared for Corpus Christi Regional Economic Development Corporation

Hanson Professional Services Inc. Project No. 18L0013 Task 1000

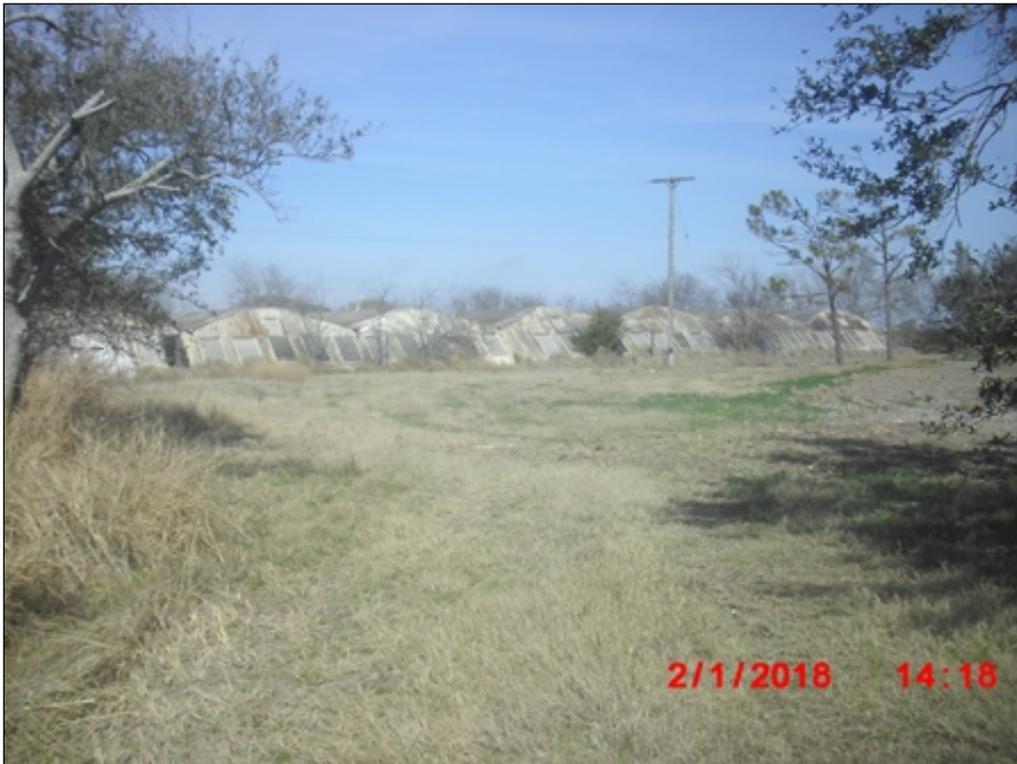
88. Photo taken in central portion of subject property facing northwest. The exterior of the building in photo #86 can be seen. The structure was previously used as a greenhouse operation but is now abandoned and appears to be leaning.

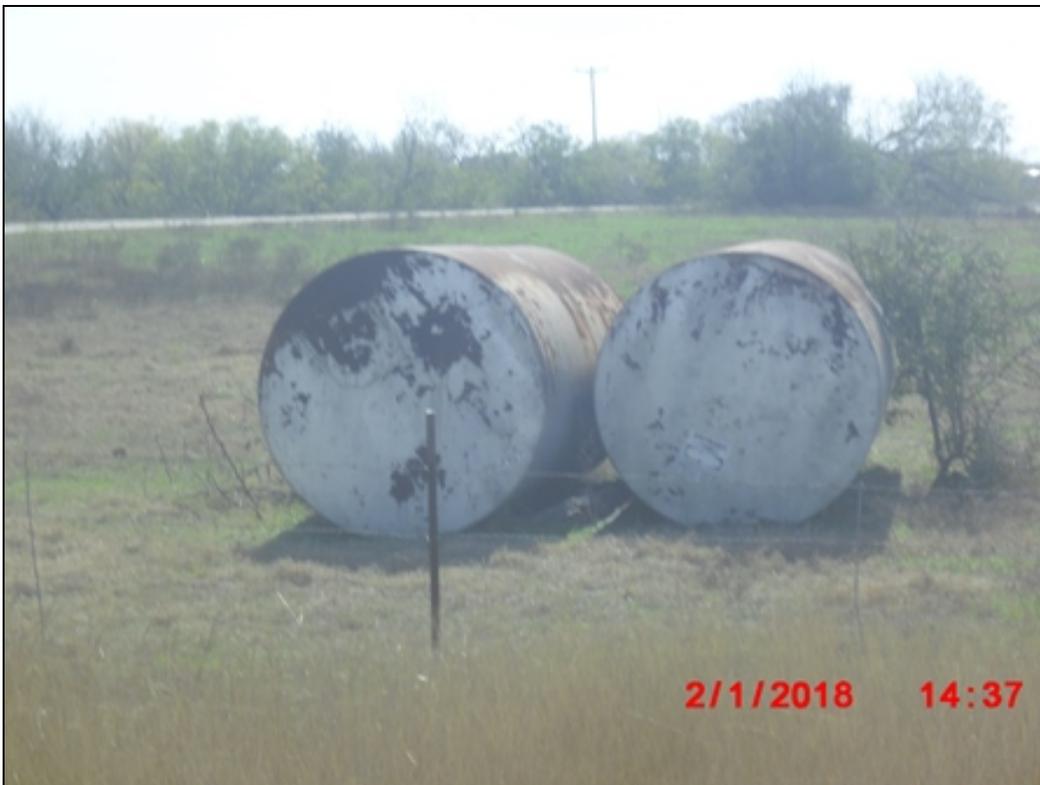
94. Photo taken in northwest portion of subject property facing south. What appear to be out of use tractor diesel tanks can be seen.

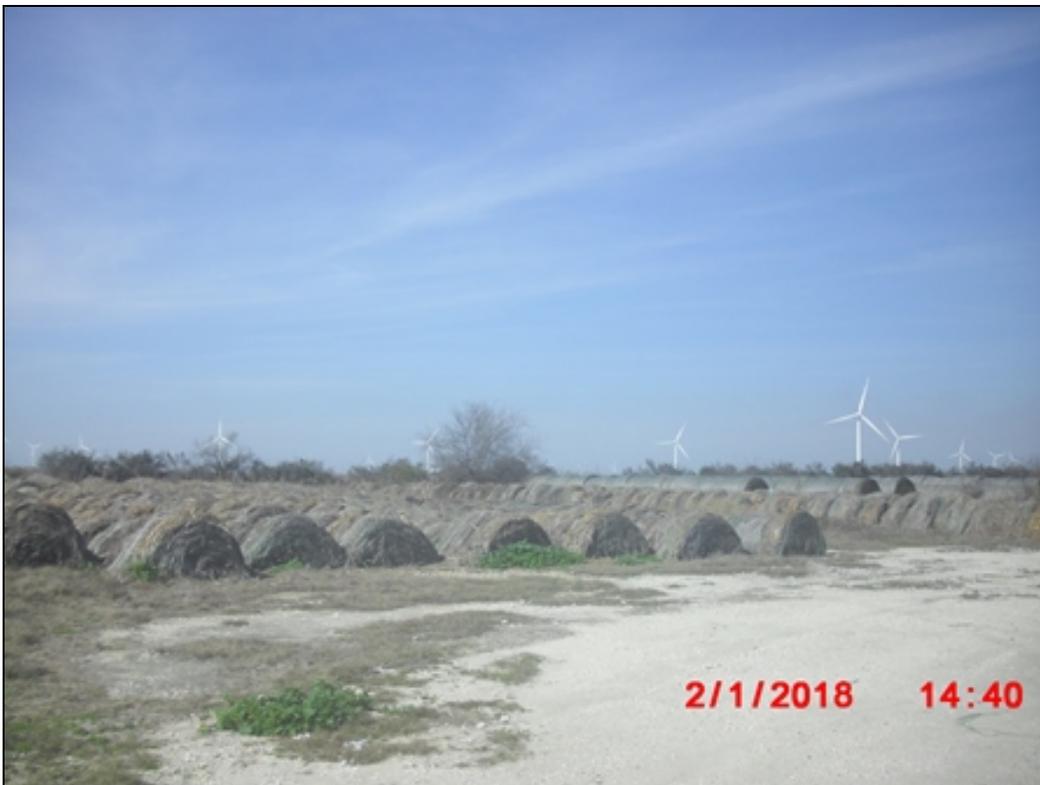
96. Photo taken in northwest portion of subject property facing north. A pad area possibly associated with past oil and gas exploration that is being used to store hay bales can be seen.

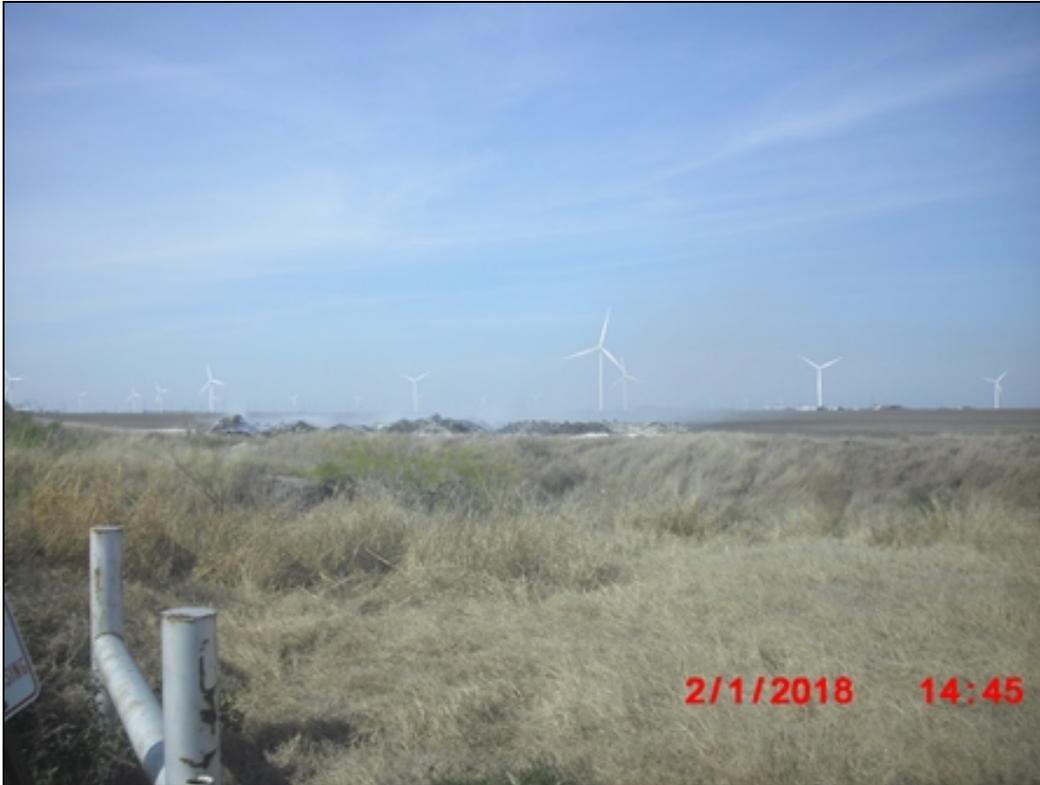
Piles of harvested cotton were being burned on two locations on the subject property during the site visit. Many other piles appeared to have been previously burned. Piles of brush, mulch, and lumber were observed in the north central portion of the subject property. To the north of the subject property, an area was observed where illegal dumping of household items such as furniture and children's toys had occurred.

99. Photo taken in north portion of subject property facing north. Piles of harvested cotton can be seen burning on the subject property on the west side of the ditch.

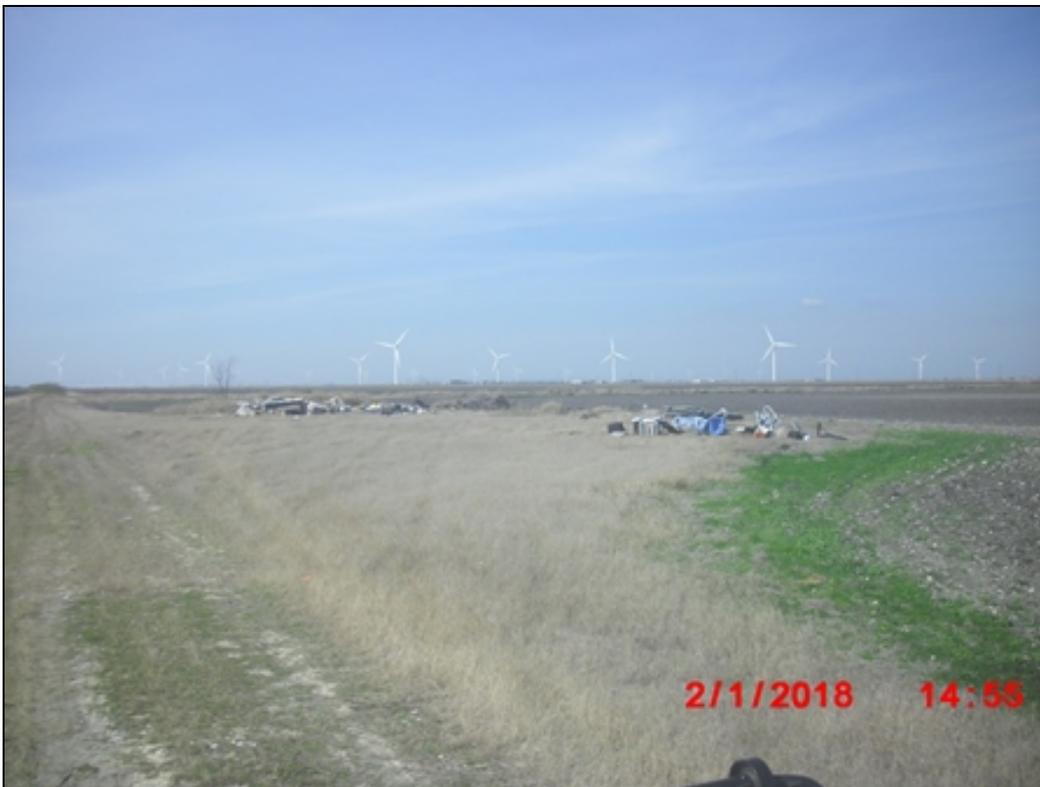
102. Photo taken along northern property boundary facing northwest. An area where illegal dumping of household items has occurred can be seen to the north of the subject property.

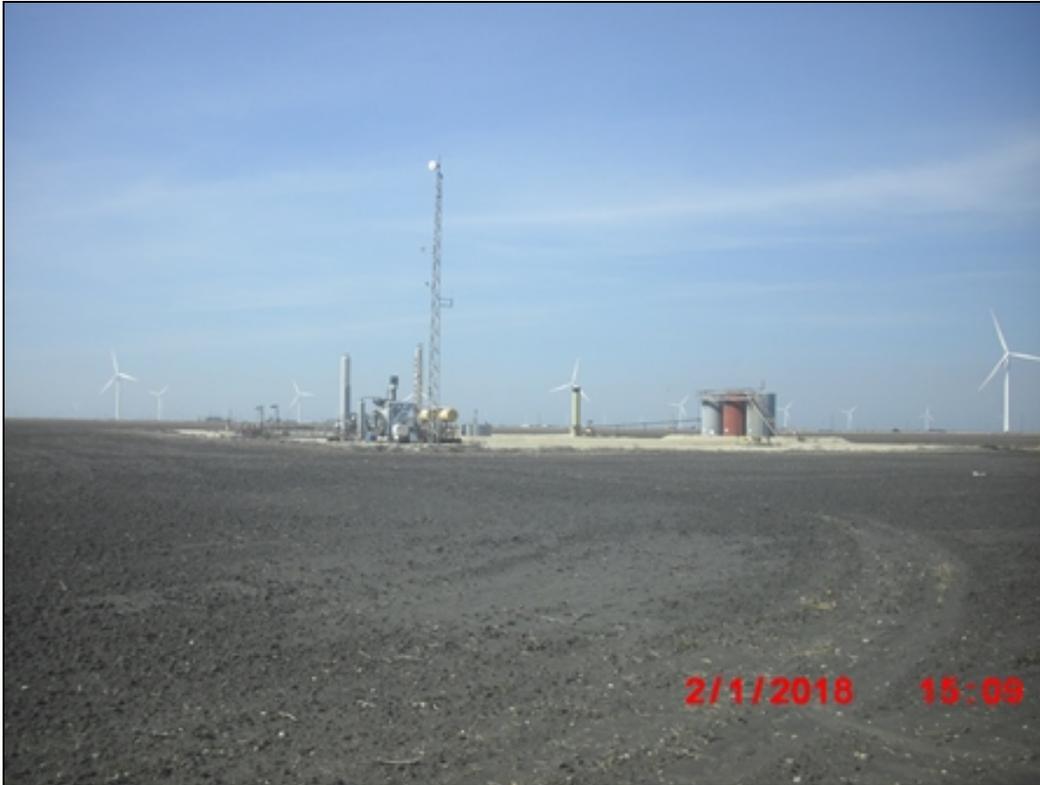
105. Photo taken approximately 1,000 feet north of subject property facing northwest. A natural gas production facility can be seen.

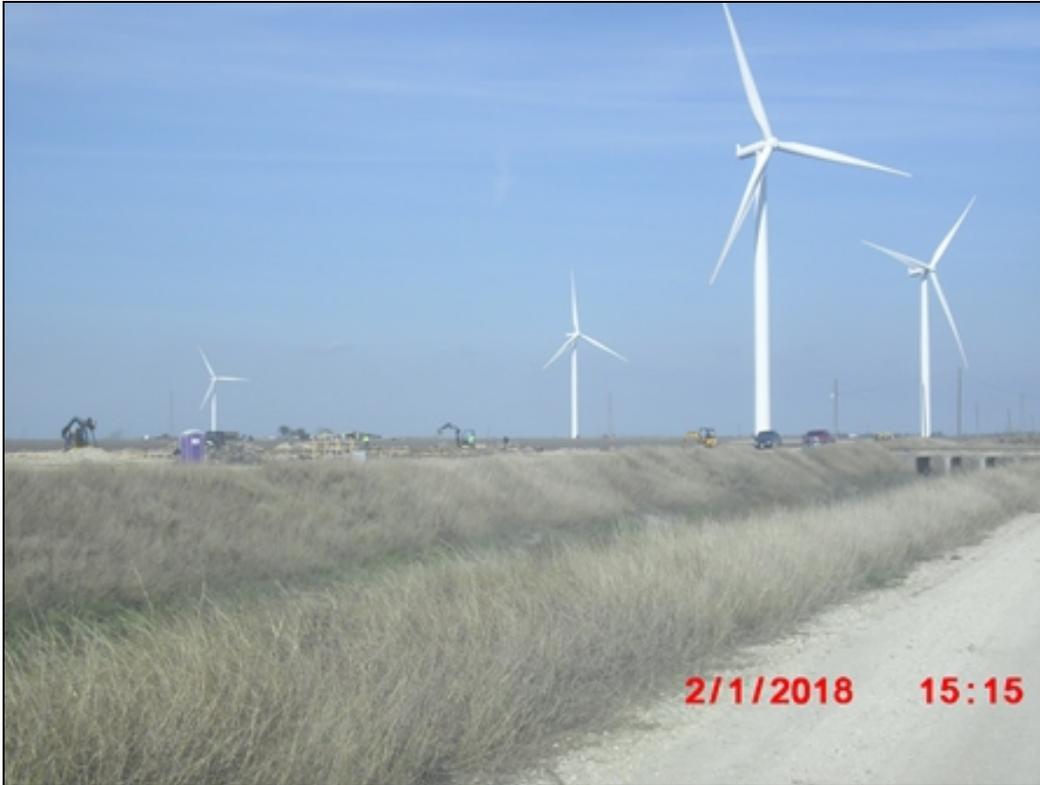
107. Photo taken along northern portion of subject property facing north. The ditch that crosses the subject property north/south and wind turbines can be seen. A construction project occurring on the north portion of the subject property can also be seen.

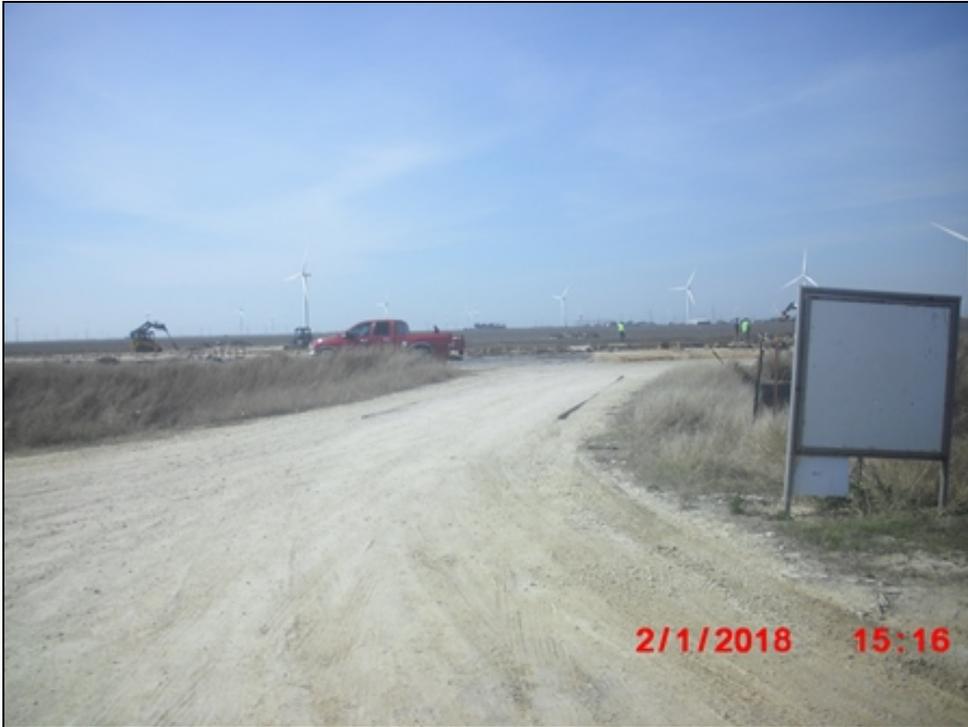
109. Photo taken near north point of subject property facing west. A construction project occurring on the northern portion of the subject property can be seen.

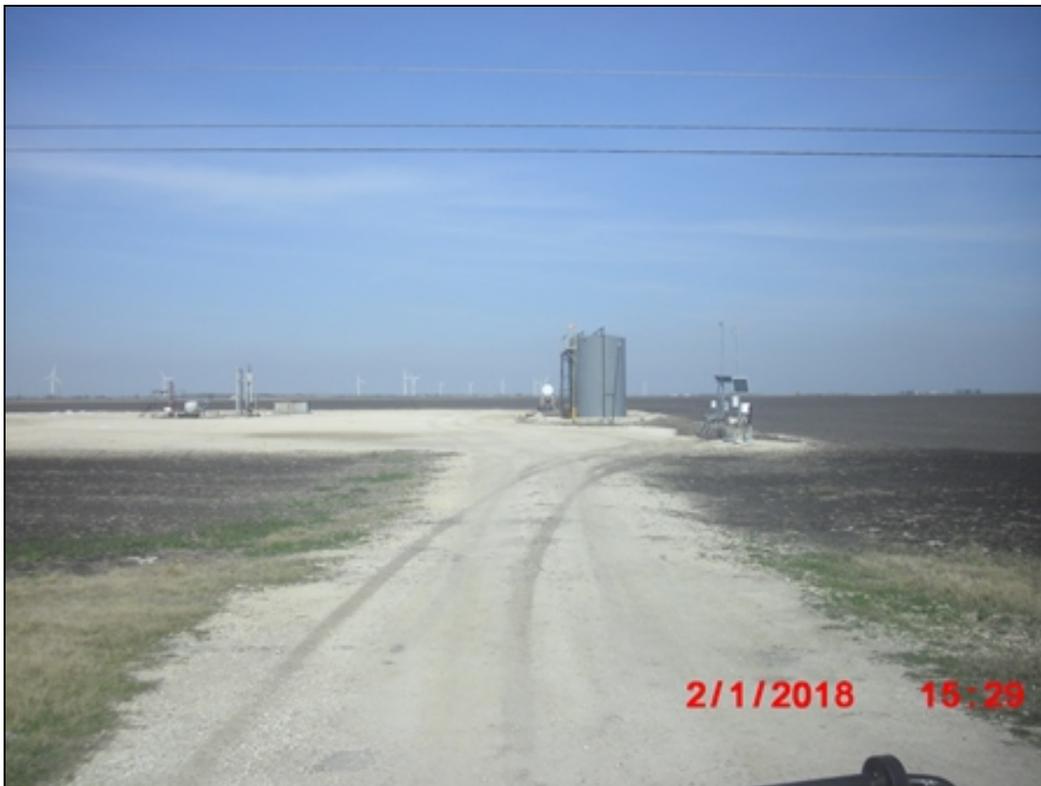
112. Photo taken near center of southern property boundary facing northeast. A gas well surface tree and above ground storage tanks can be seen at this production facility.

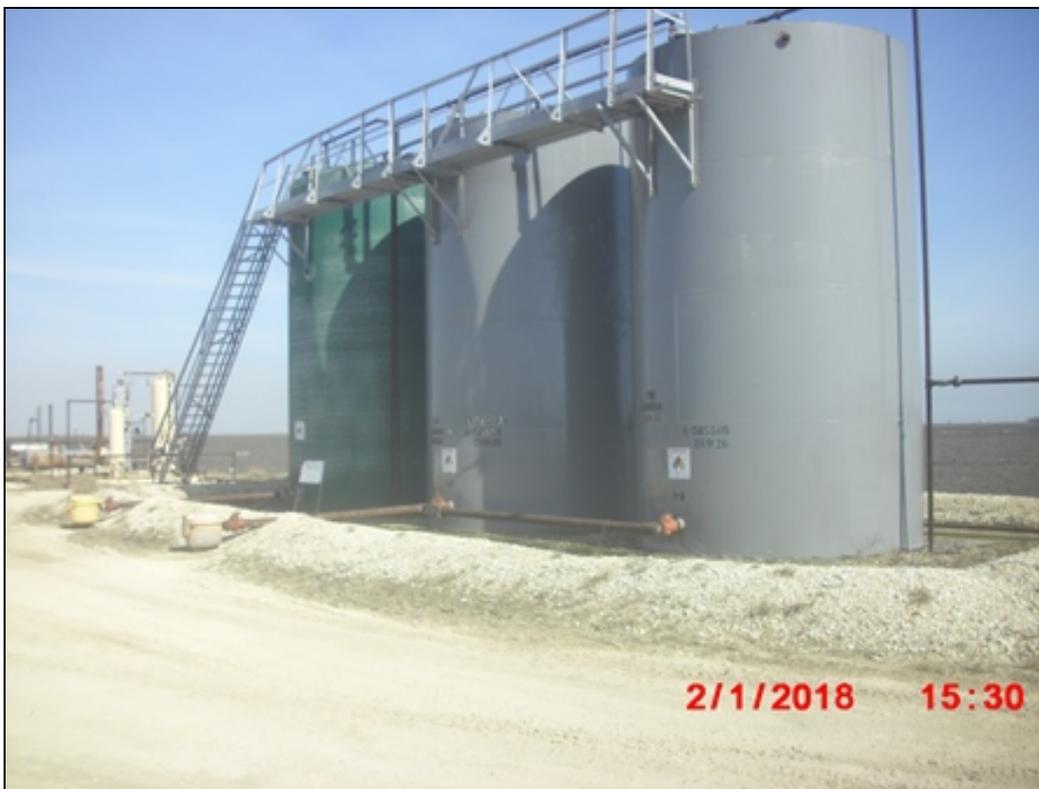
113. Photo of aboveground storage tanks at production facility on the subject property. The tank on the left was labeled as containing produced water and the two other tanks were labeled as containing condensate. A secondary containment berm was present around the tanks.

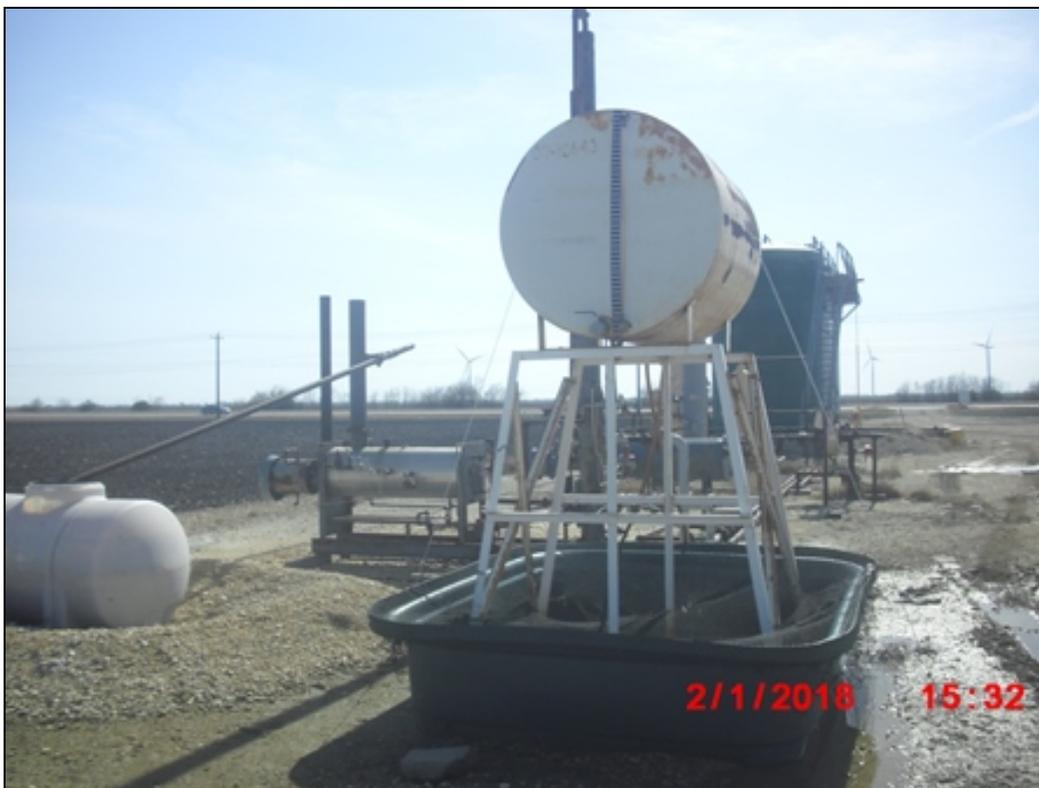
114. Photo of small aboveground storage tank present at production facility on the subject property. This tank was labeled as containing triethylene glycol, which may be used to dehydrate natural gas, and was provided with secondary containment.

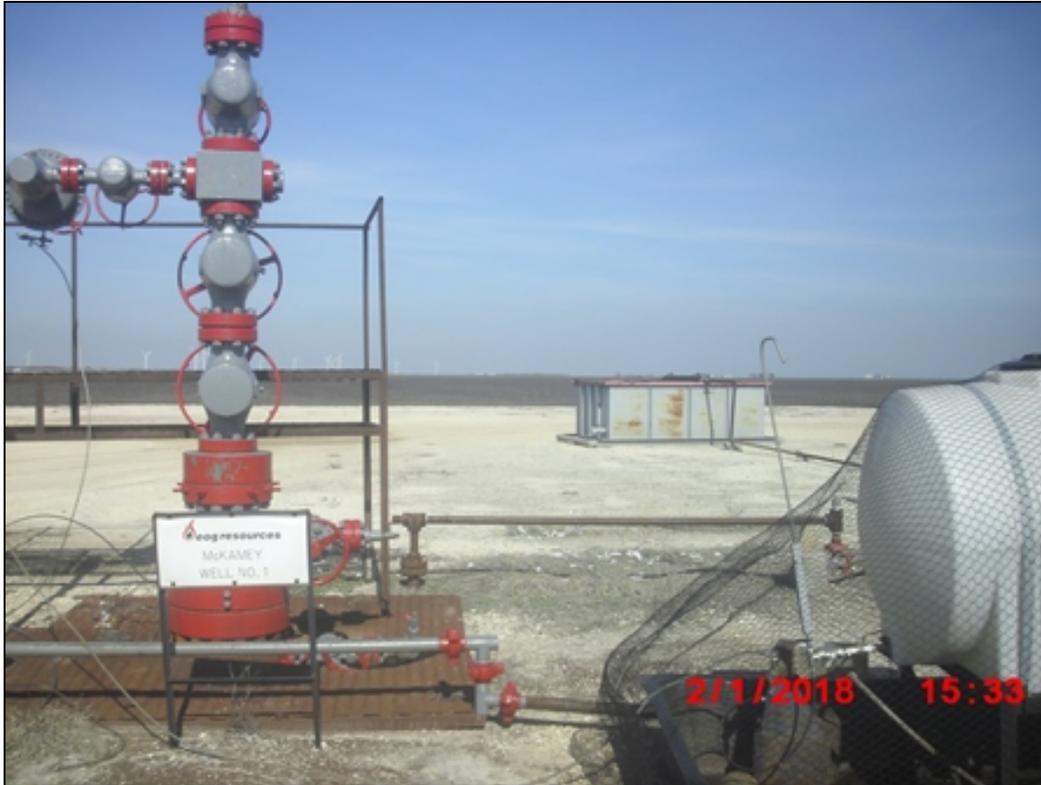
115. Photo taken of gas well located at production facility on the subject property. The well is identified as McKamey Well No. 1.

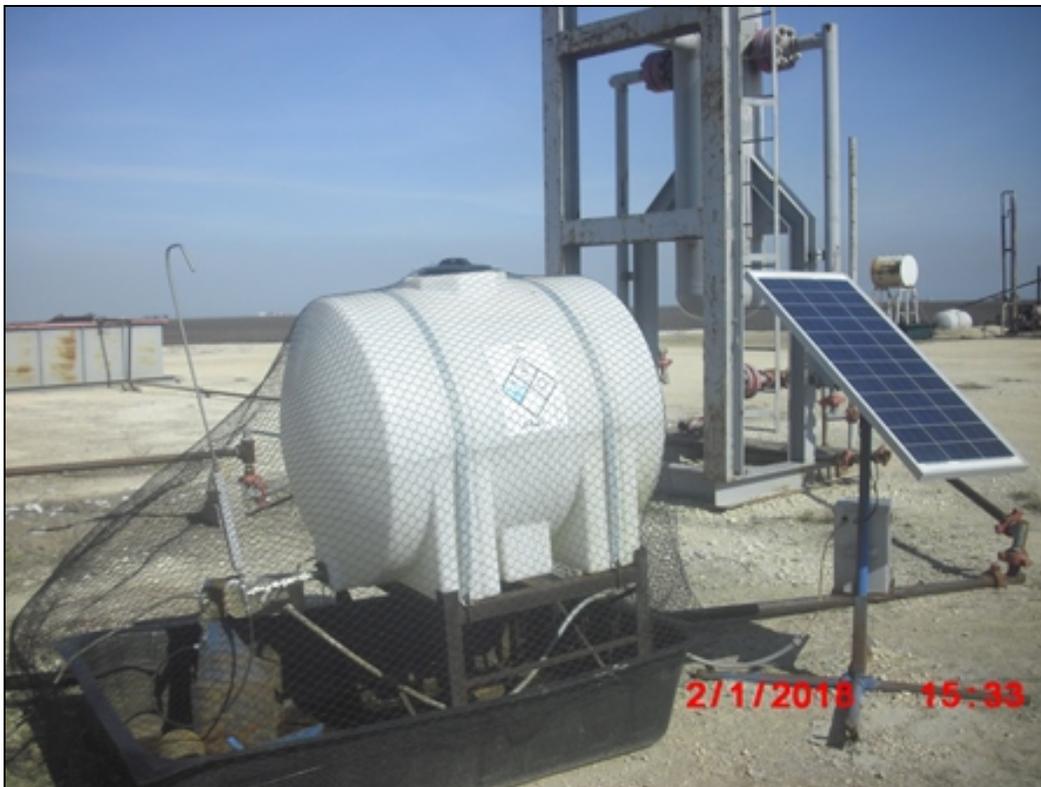
116. Photo of small storage tank located at production facility on the subject property. This tank was labeled as containing PFR-23 and was provided with secondary containment.

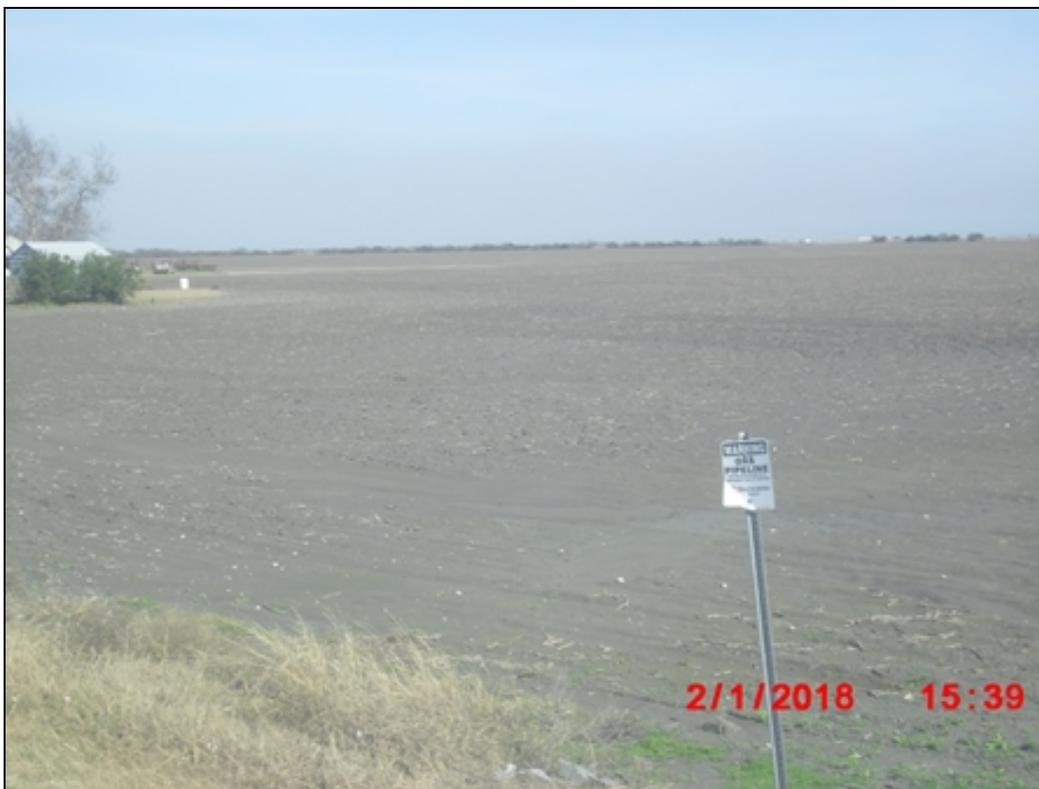
119. Photo taken approximately 1,500 feet north of southwest corner of subject property facing northeast. A warning marker for a gas pipeline can be seen in front of farmland of the subject property.

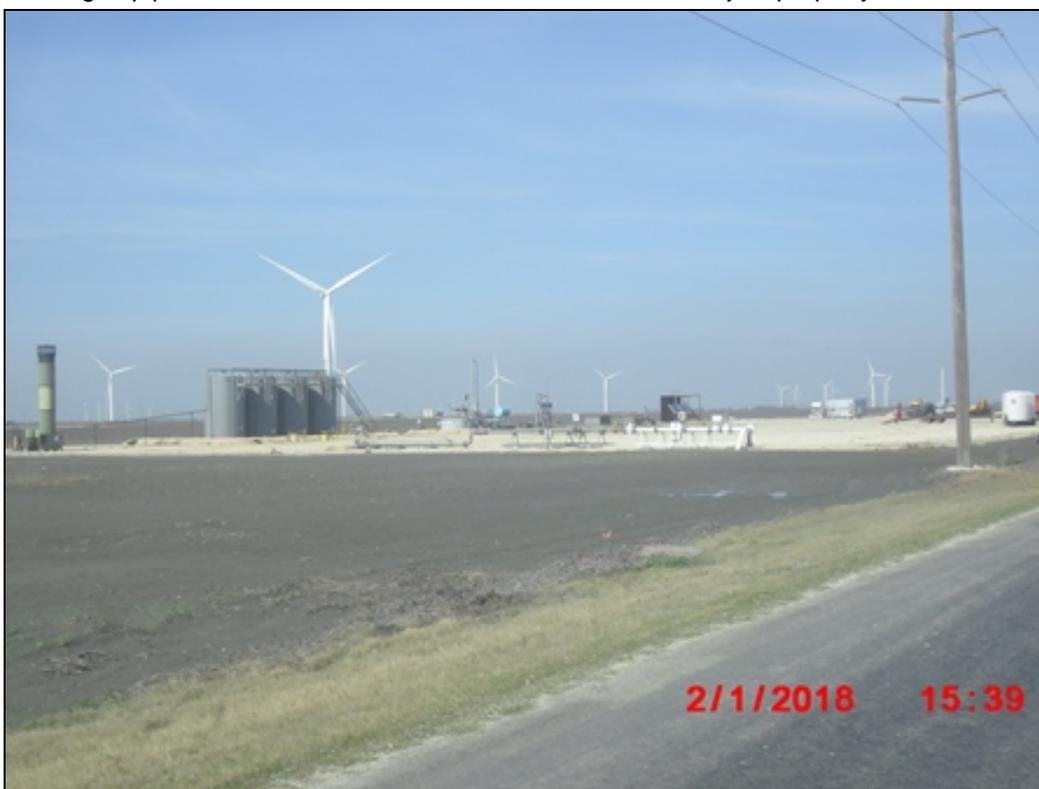
120. Photo taken approximately 1,500 feet north of southwest corner of subject property facing northwest. A production facility with aboveground storage tanks, aboveground pipeline appurtenances, and a gas flare can be seen across CR 3677 from the subject property. Secondary containment berms appear to be present around the aboveground storage tanks.

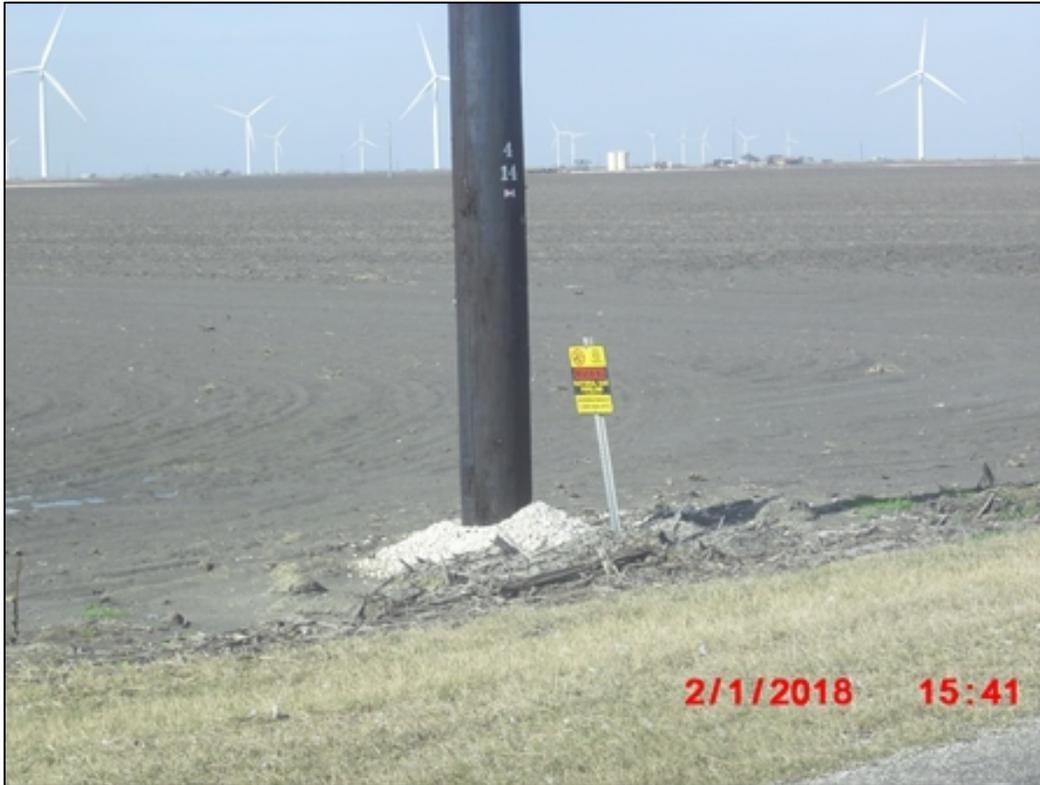
121. Photo taken approximately 3,100 feet north of southwest corner of subject property facing northwest. A warning marker for a natural gas pipeline can be seen on the property adjacent to the subject property.

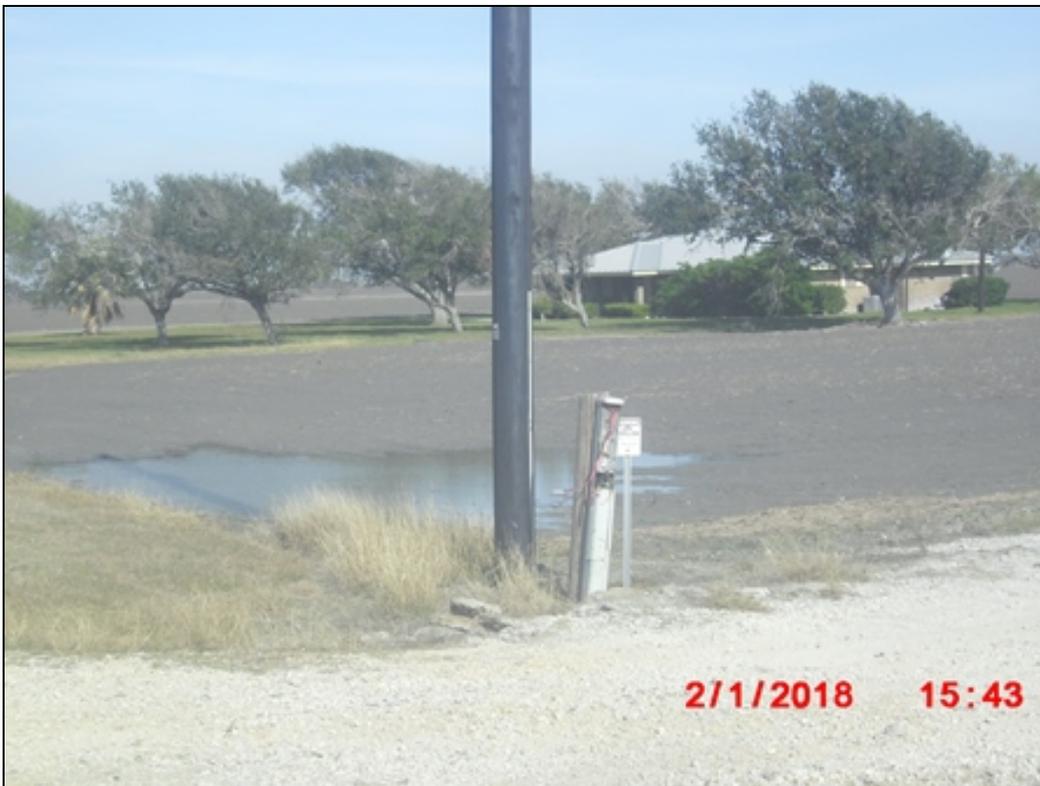
122. Photo taken approximately 3,700 feet north of southwest corner of subject property facing northeast. A warning marker for a natural gas pipeline can be seen in front of a residential property located on the subject property.

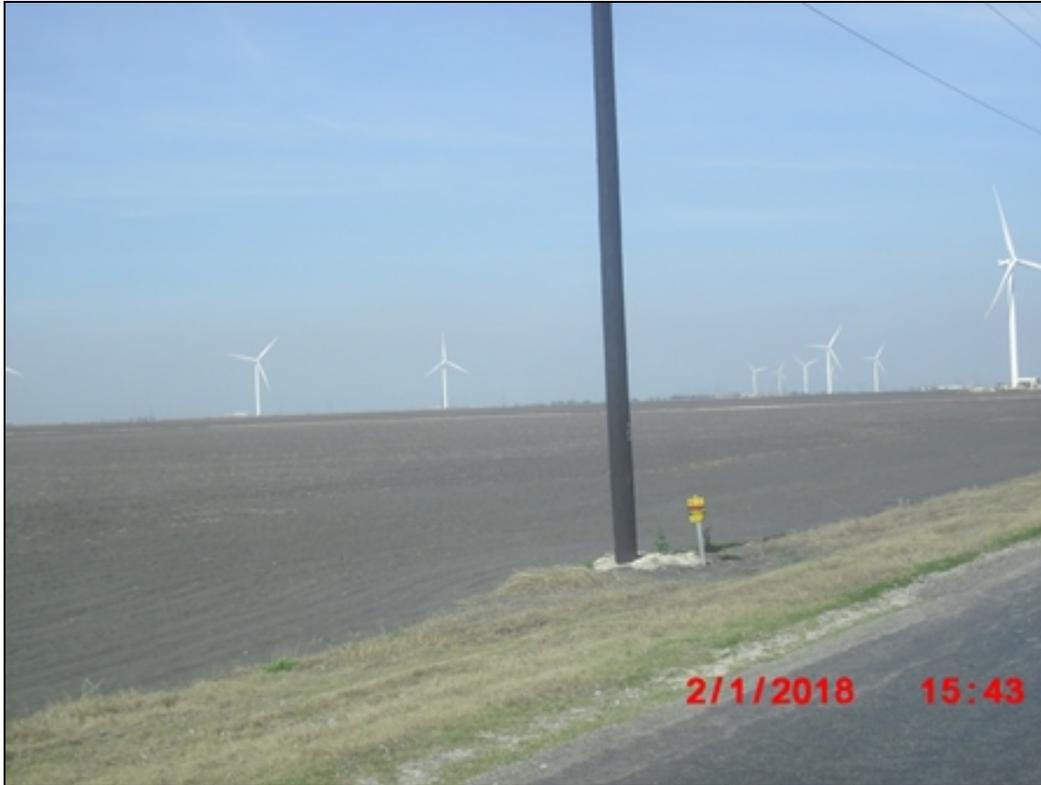
123. Photo taken approximately 3,700 feet north of southwest corner of subject property facing northwest. A warning marker for a natural gas pipeline can be seen on the property adjacent to the subject property.

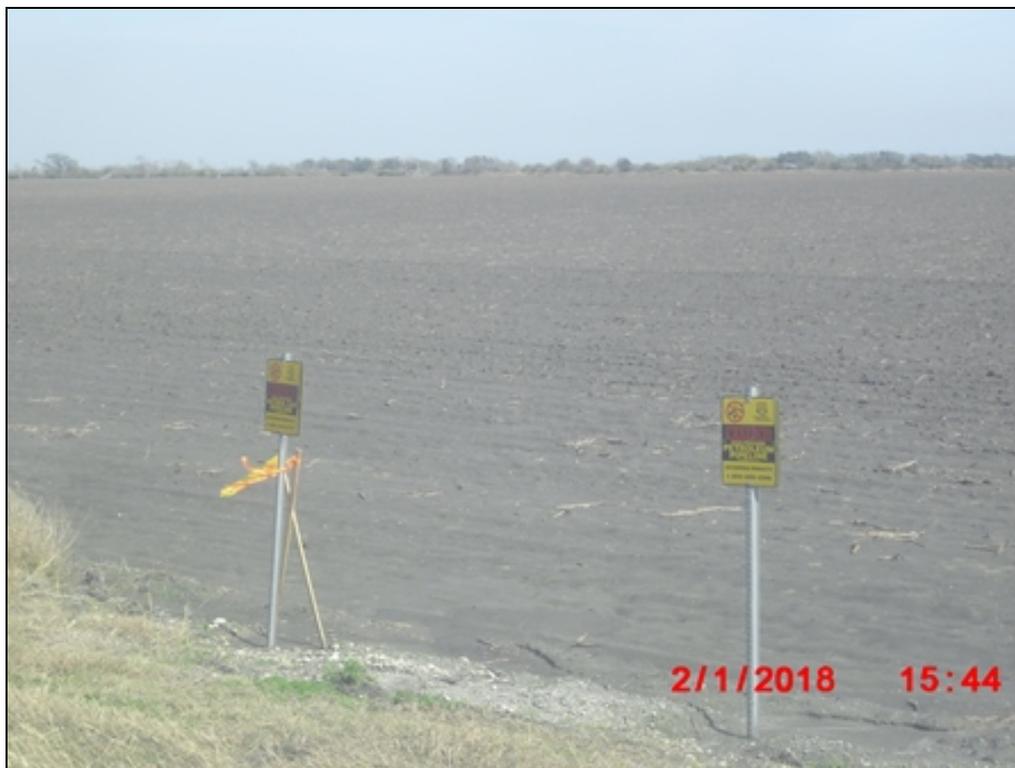
125. Photo taken approximately 4,900 feet north of southwest corner of subject property facing northeast. Warning markers can be seen on the subject property for a high pressure natural gas pipeline and a high pressure petroleum pipeline.

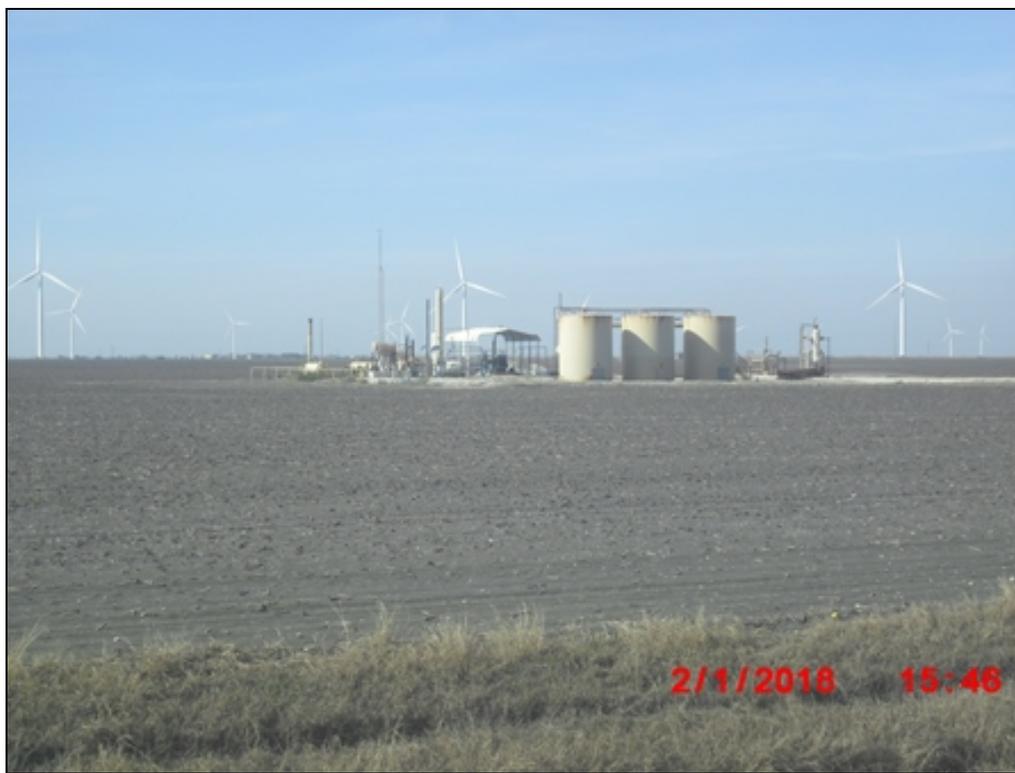
126. Photo taken approximately 5,600 feet north of southwest corner of subject property facing northwest. A production facility with a well surface tree, aboveground storage tanks, and a gas flare can be seen across CR 3677 from the subject property. Secondary containment berms appear to be present around the aboveground storage tanks.

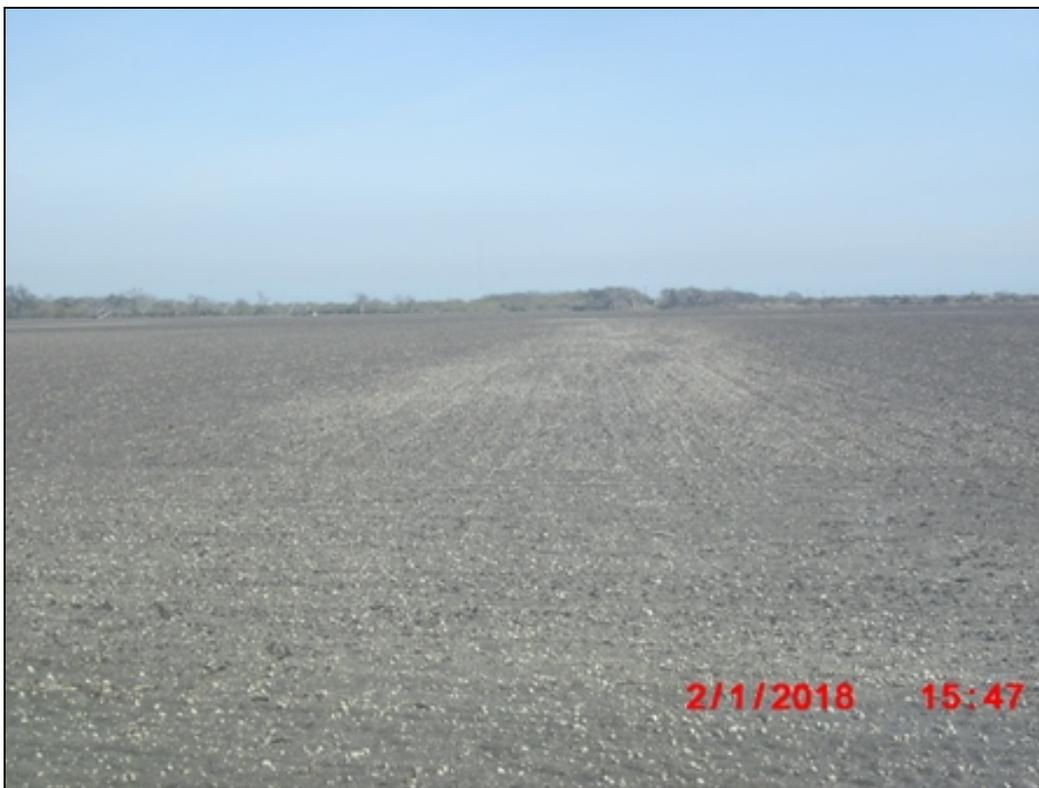
128. Photo taken approximately 6,820 feet north of southwest corner of subject property facing southeast. Remnants of an old well pad can be seen on the farmland of the subject property.

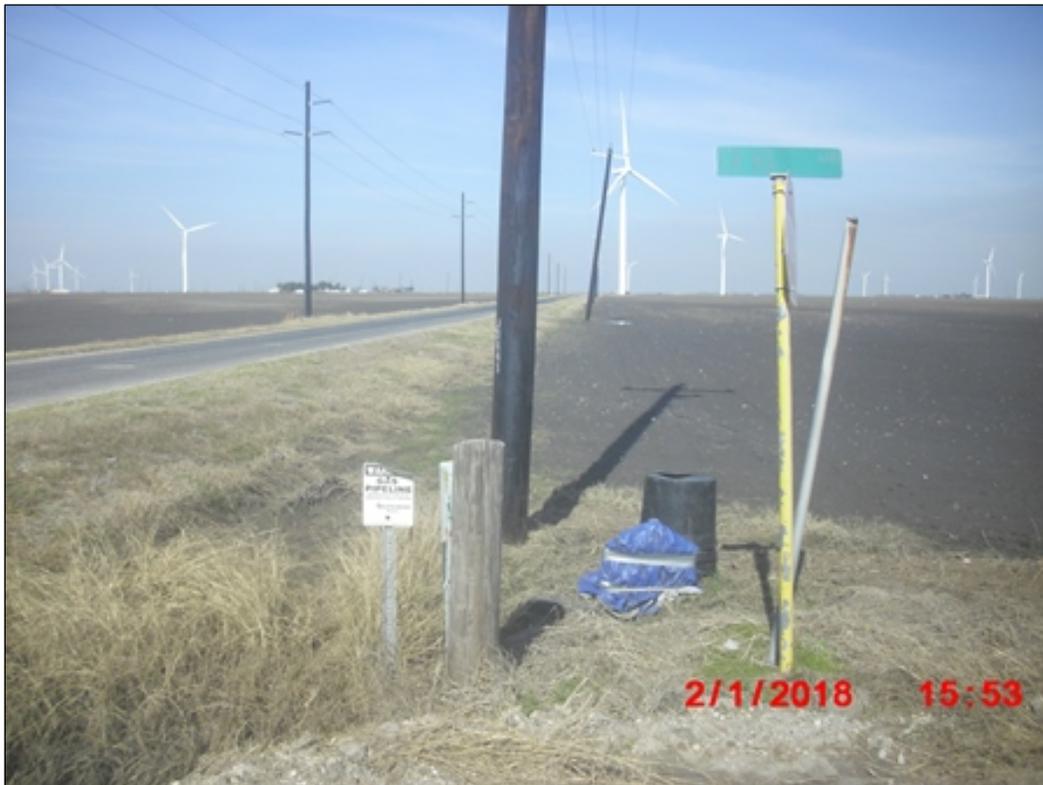
132. Photo taken near northwest corner of subject property facing north. A warning marker for a gas pipeline can be seen.
